# Portofino Condominium Apts. of Palm Beach, Inc.

Inspected: January 15, 2025 • Revised on: February 07, 2025  
West Palm Beach, FL

**STRUCTURAL INTEGRITY  
RESERVE STUDY**

**PORTOFINO  
2600**

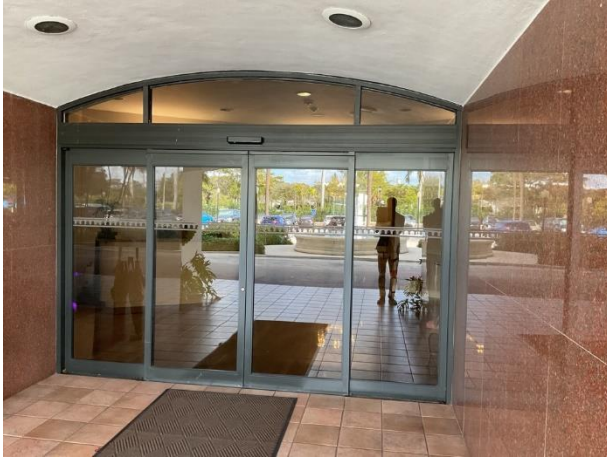
**Condition:** Good to fair overall at the lobby and the metal doors were reported in unsatisfactory condition due to them not being impact grade.

**Lobby doors and windows**

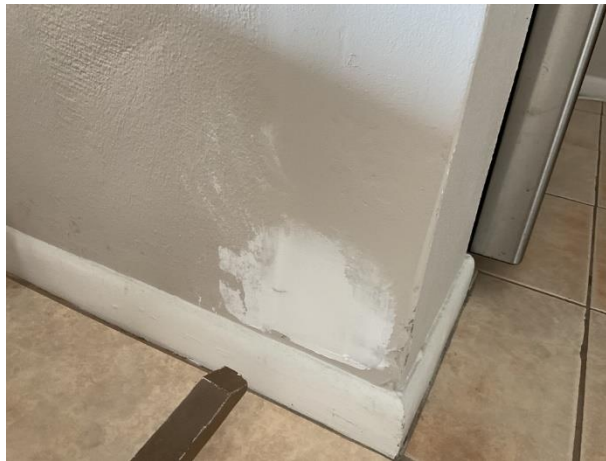
**Condition:** Good to fair overall with previous wall repairs evident.

**Previous wall repairs**

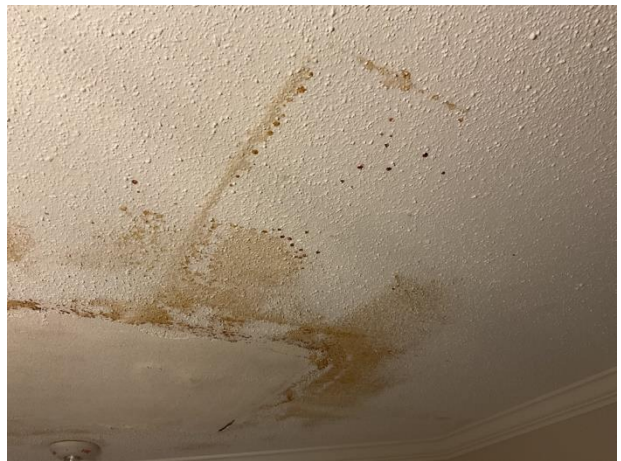
**Condition:** Good overall; We note one section of stains that occurred due to water damage.

**Stains from water damage**

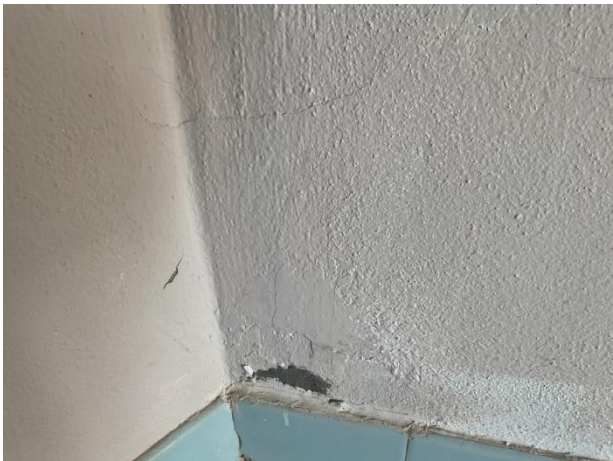
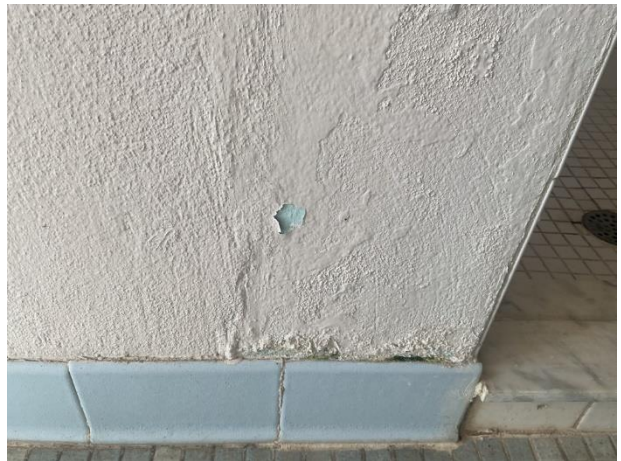
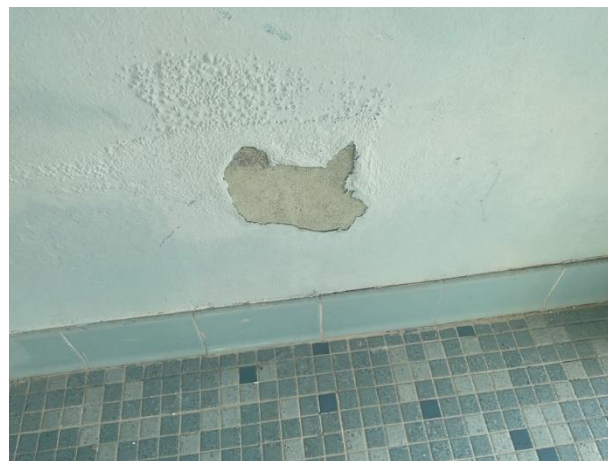
**Condition:** The building rest rooms are in good to fair overall condition and the pool house rest rooms are in fair to poor overall condition with paint deterioration evident.

**Pool house paint deterioration**

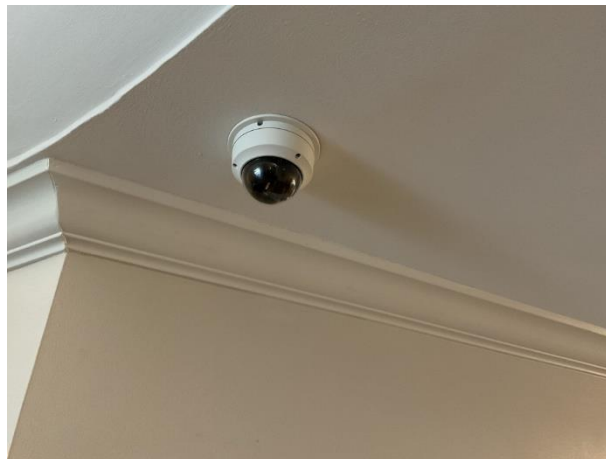
**Condition:** Reported unsatisfactory with operational deficiencies

**Security system**

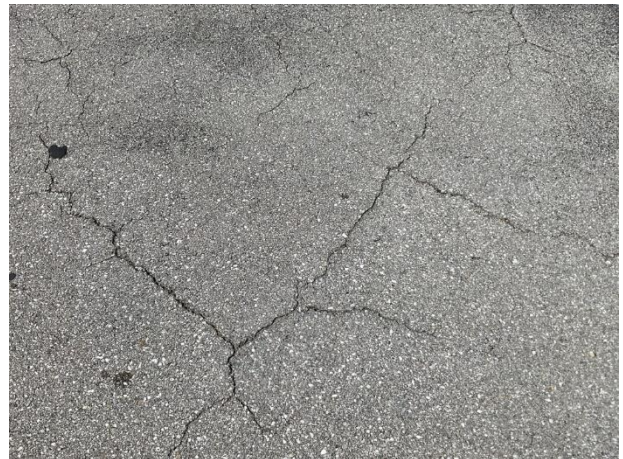
**Condition:** Fair overall with periodic cracks and seal coat deterioration evident. We note centerline deterioration at the pavement due to the drainage system.

Pavement cracks

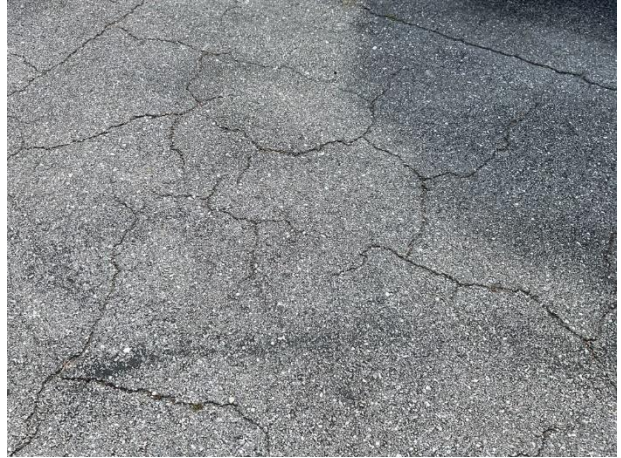
**Pavement cracks**

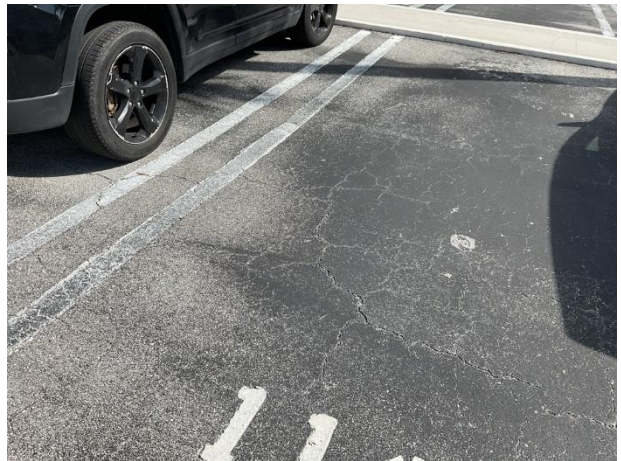
**Pavement cracks and seal coat deterioration**

**Useful Life:** 15- to 20-years with the benefit of patch repairs and seal coat events every three- to five-years

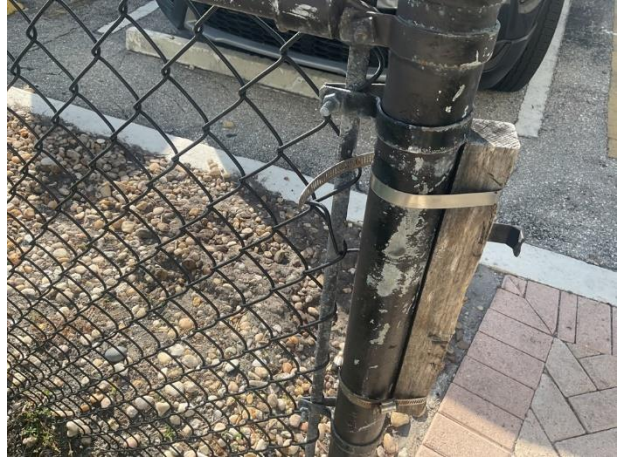
**Condition:** Fair to poor overall with periodic damage evident.

**Fence coating deterioration**

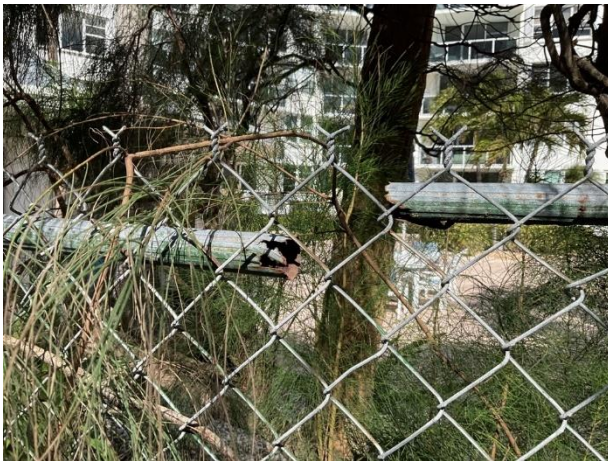
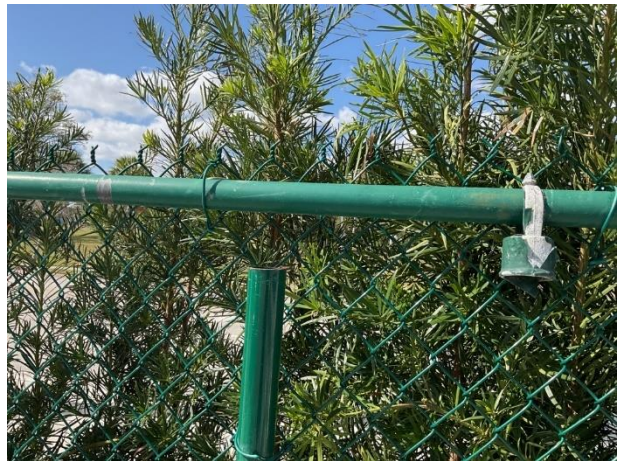
**Fence damage**

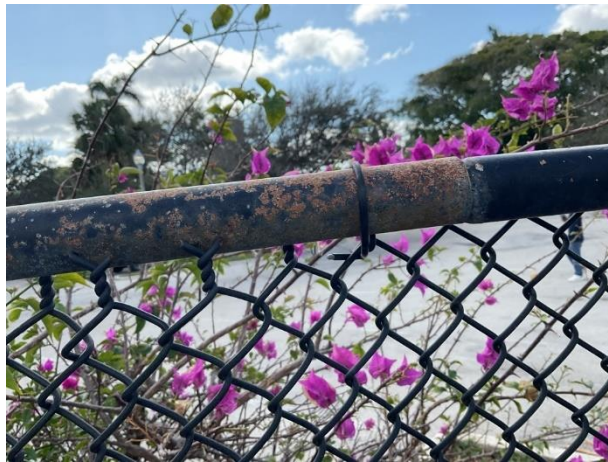
**Condition:** Fair to poor overall with periodic rust evident.

Fence post rust

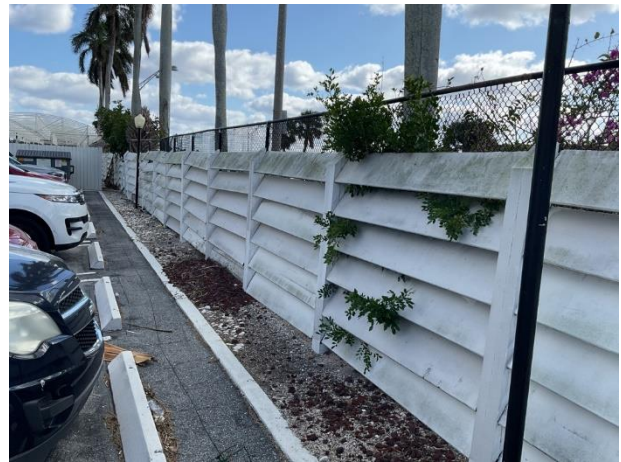
**Condition:** Poor overall with periodic wood rot and paint finish deterioration evident.

**Wood fence with finish deterioration**

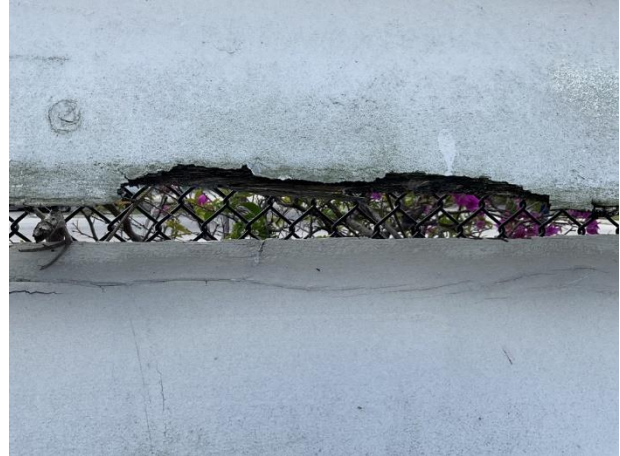
**Fence wood rot**

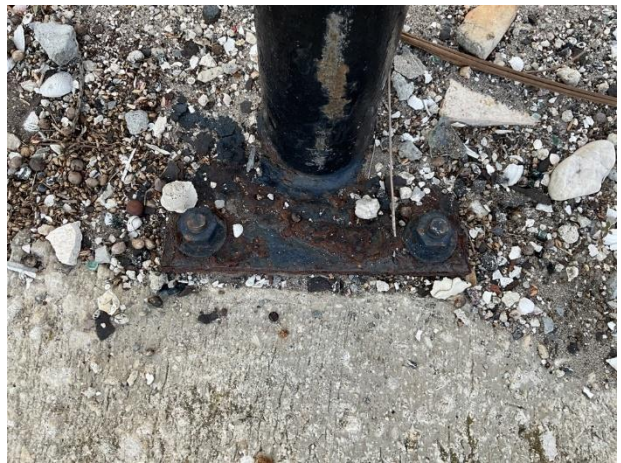
**Condition:** Fair overall with rust and finish deterioration evident.

Finish deterioration and rust

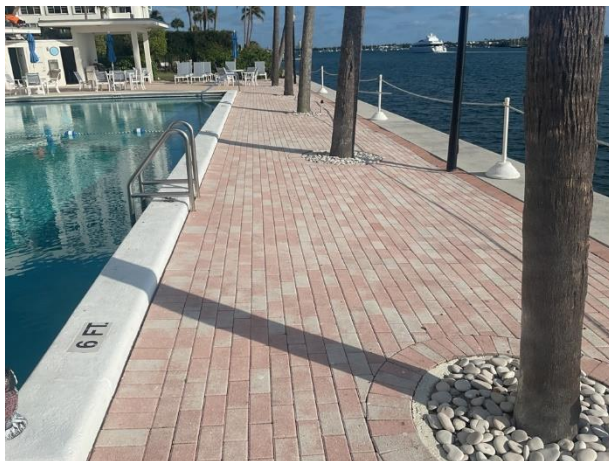
**Condition:** Good to fair overall with isolated settlement evident.

Paver pool deck overview

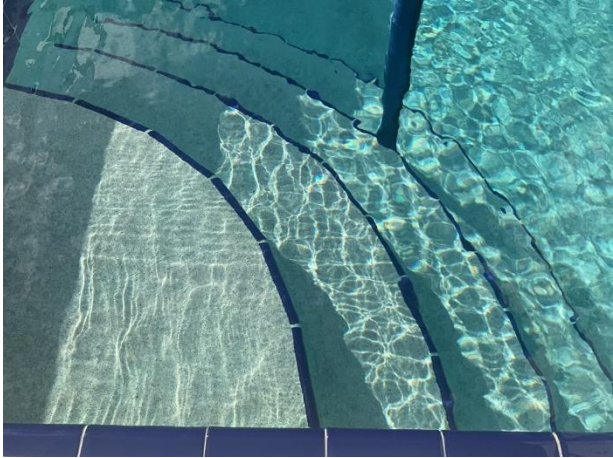
**Condition:** Fair overall with periodic discoloration evident.

**Pool plaster overview**

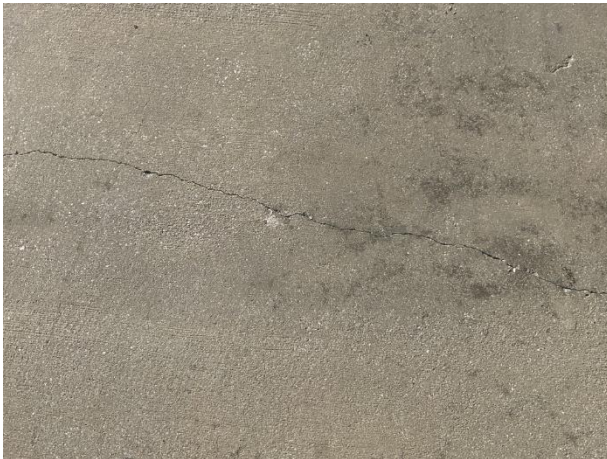
**Conditions:** Fair overall; We note isolated cracks and one section with evidence of water infiltration causing erosion and paver settlement.

Wall cracks

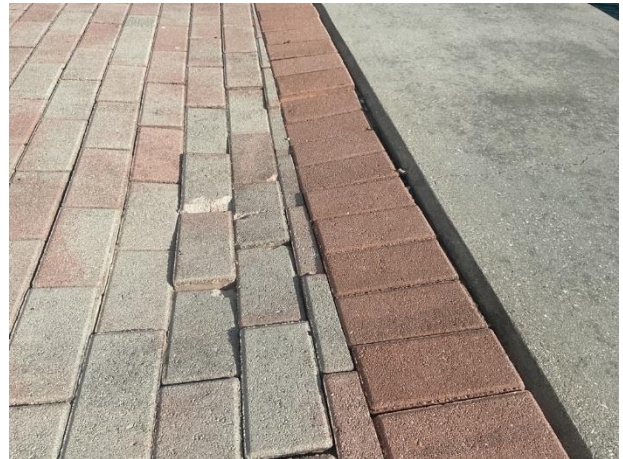
Erosion at bulkhead backside causing paver settlement

**Useful Life:** Inspections and capital repairs every 10- to 15-years
