# Portofino Condominium Apts. of Palm Beach, Inc.

Inspected: January 15, 2025 • Revised on: February 07, 2025  
West Palm Beach, FL

**STRUCTURAL INTEGRITY  
RESERVE STUDY**

**PORTOFINO  
2600**

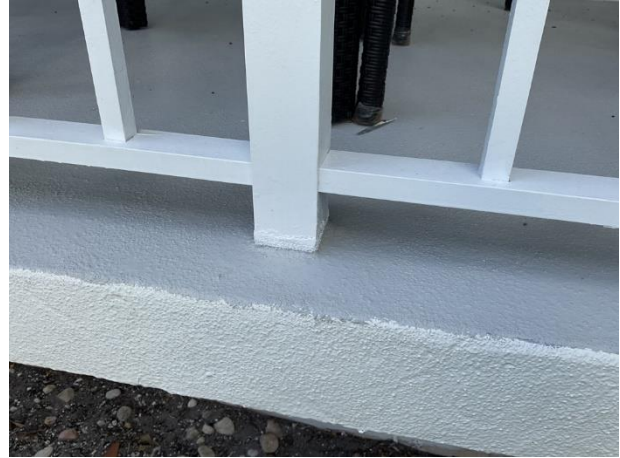
**Conditions:** The railings are in good overall condition and the railing finishes are in good condition with no significant deterioration evident.

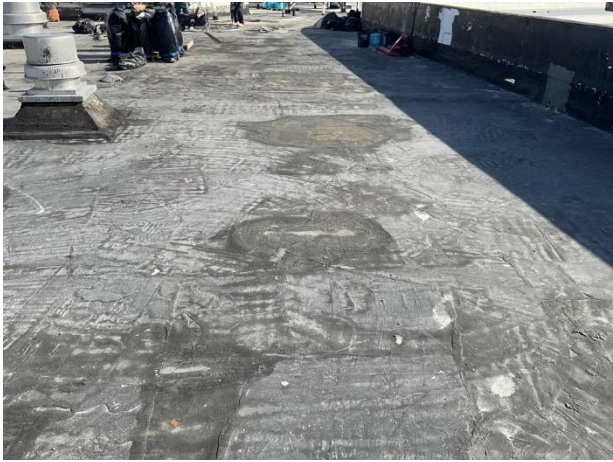
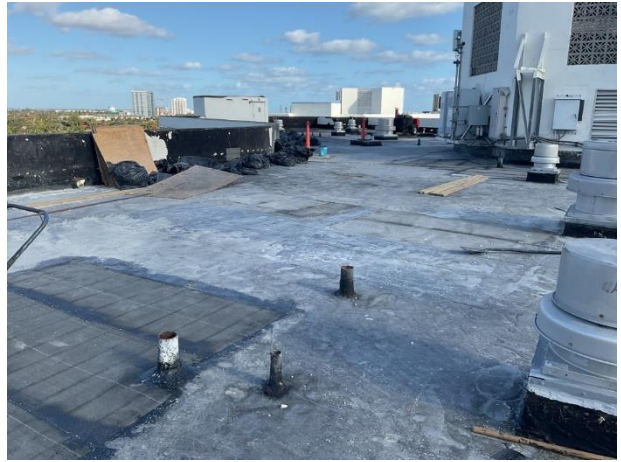
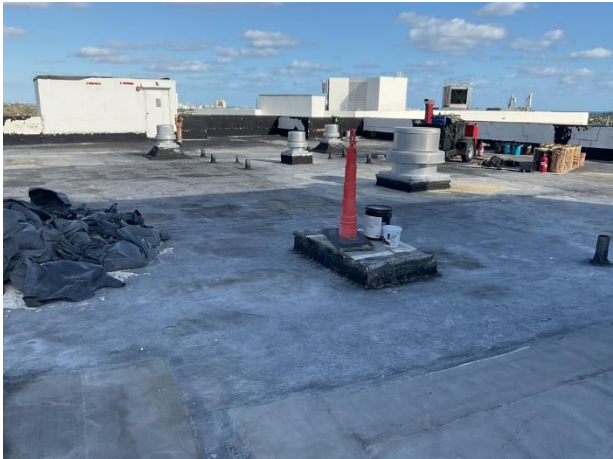
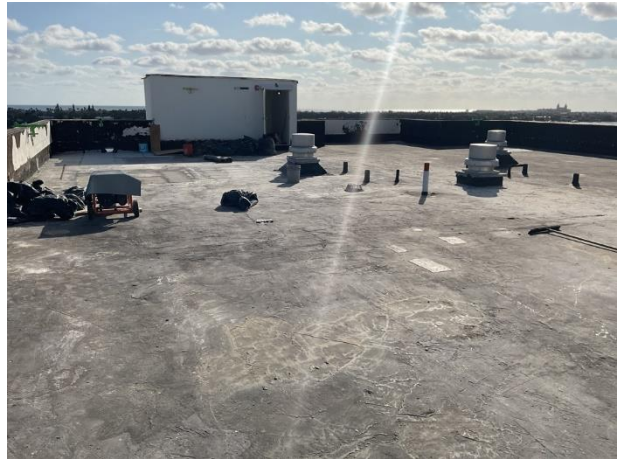
**History and Condition:** The roof was in the process of being replaced at the time of inspection. This project is being funded through means other than reserves. The Association conducts inspections of the roofs annually. We concur with this preventive maintenance practice and recommend the Association continue to fund these inspections through the operating budget.

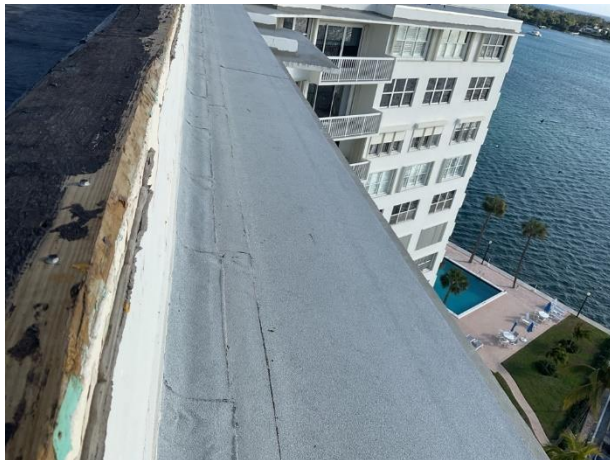
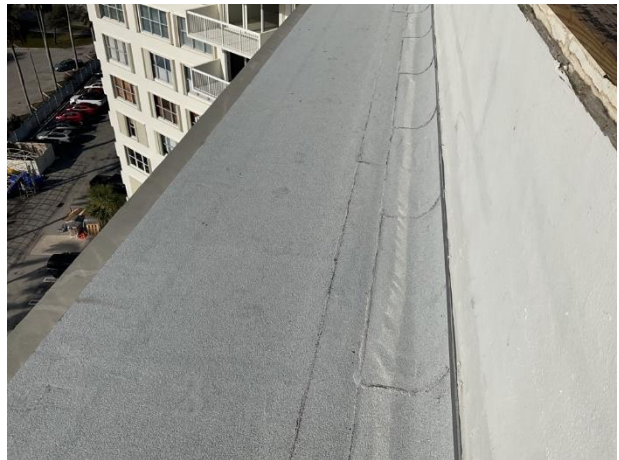
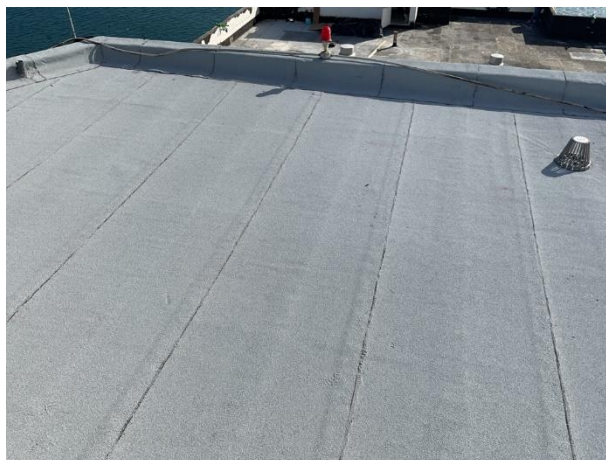
**History and Condition:** The roofs were in the process of being replaced at the time of inspection. This project is being funded through means other than reserves. The Association conducts inspections of the roofs annually. We concur with this preventive maintenance practice and recommend the Association continue to fund these inspections through the operating budget.

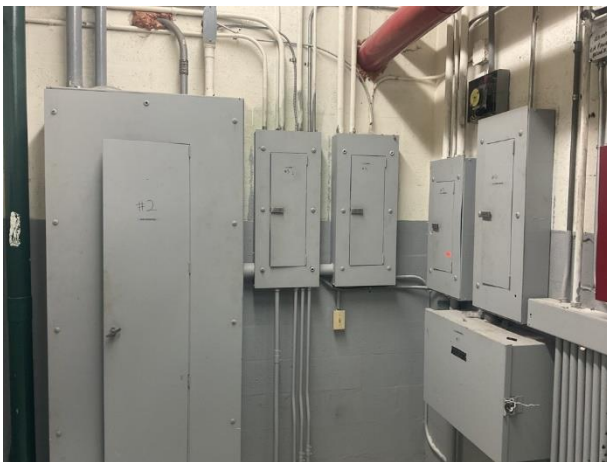
**Condition:** Reported satisfactory without operational deficiencies. We note the following:

- The date of the last thermoscan was unavailable to us.
- No excessive buzzing/humming was present at the transformers we observed.
- No obvious combustible material storage was observed in electrical rooms. However, our inspection is not exhaustive and the Association should conduct periodic inspections of the electrical rooms to ensure compliance with 10.18.5 of NFPA 1.
- The electrical rooms we observed were properly labeled.
- No obvious exposed wires were observed during our site inspection. However, our inspection is not exhaustive and the Association should conduct periodic inspections of the electrical rooms to ensure no unsafe conditions develop.
- Rust was not present at electrical panels. Continual monitoring of the panels is prudent to ensure excessive moisture is not present at them.
- No apparent water was observed in or near the electrical rooms.

Electrical system main panels

We recommend the Association conduct thermoscans of the distribution panels and circuit protection panels, and inspections of the transformers for any indications of arcing,

burning or overheating on a regular basis, funded through the operating budget. Verification of the integrity of all connection points minimizes the potential for arcing and fires.

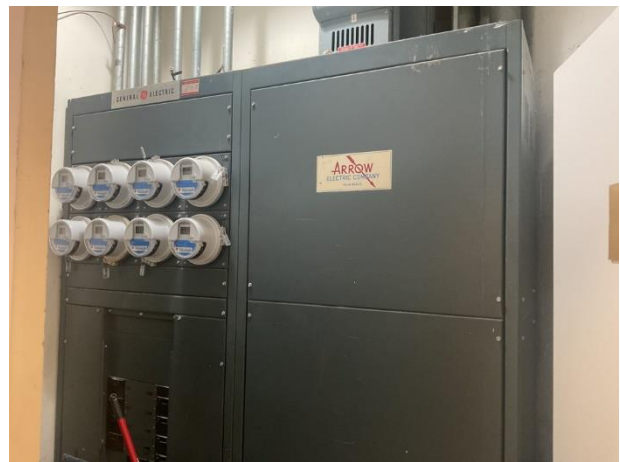
Electrical system components

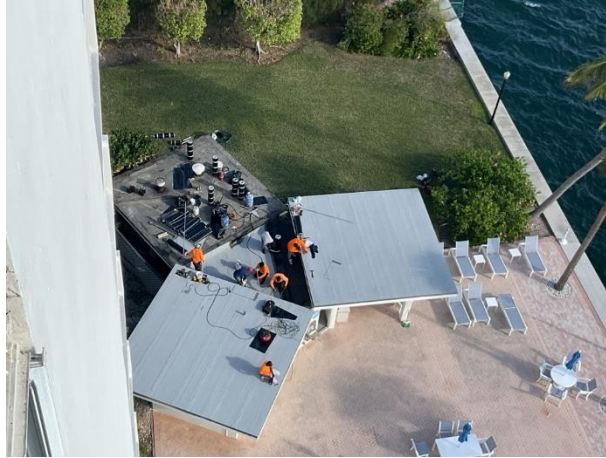
**History and Condition:** The roof was in the process of being replaced at the time of inspection. This project is being funded through means other than reserves. The Association conducts inspections of the roofs annually. We concur with this preventive maintenance practice and recommend the Association continue to fund these inspections through the operating budget.

**Modified bitumen roof at the pool house**

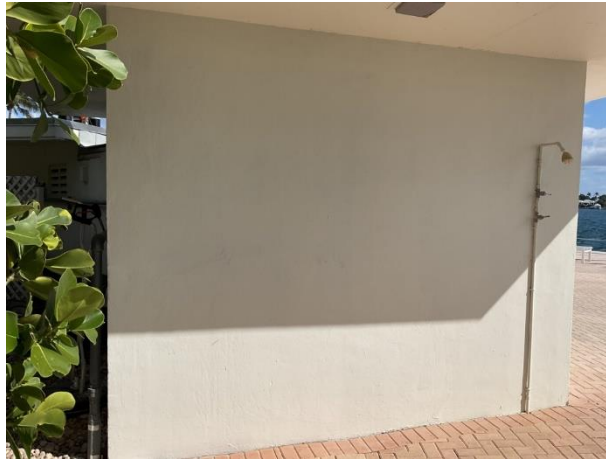
**Condition:** Good overall with no significant deterioration evident.

**Stucco wall finishes at the pool house**

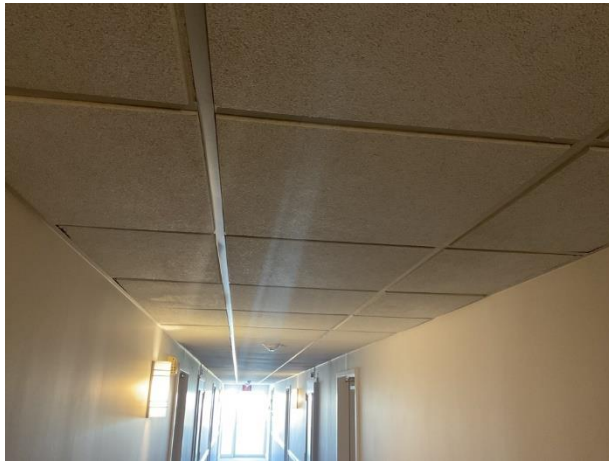
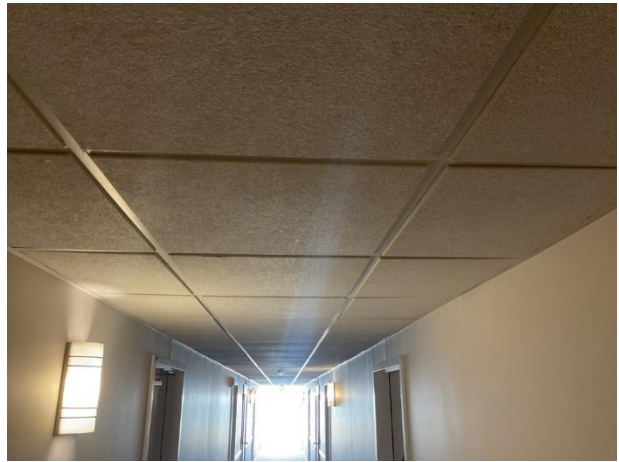
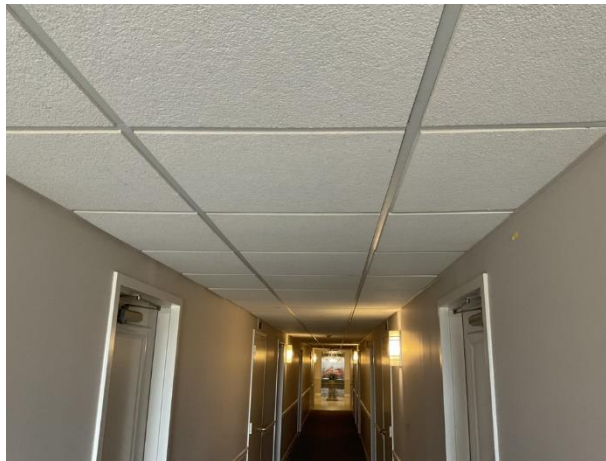
**Condition:** Good overall with no significant deterioration evident.

Acoustical ceiling tiles

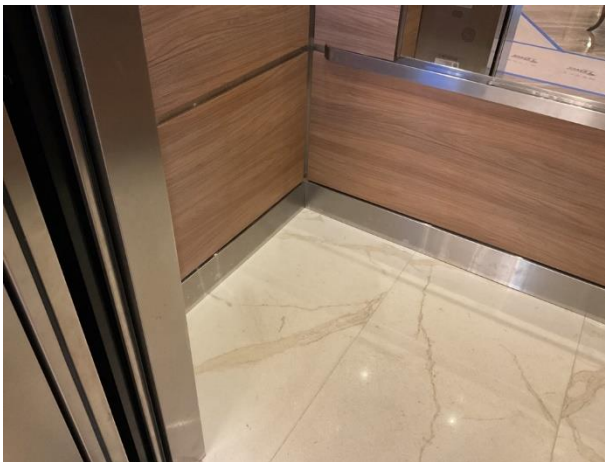
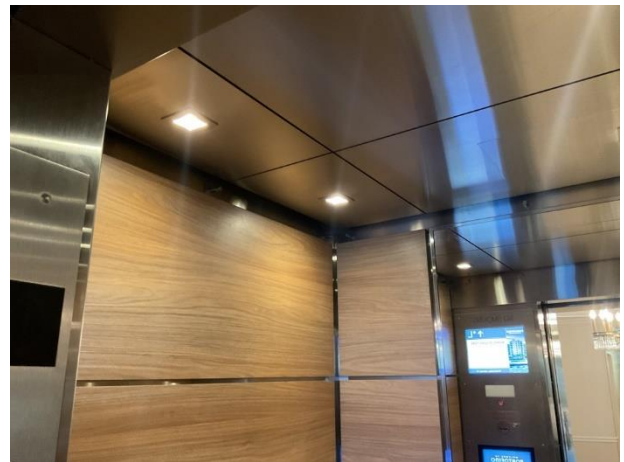
**Condition:** Good overall with no significant deterioration evident.

Elevator cab finishes

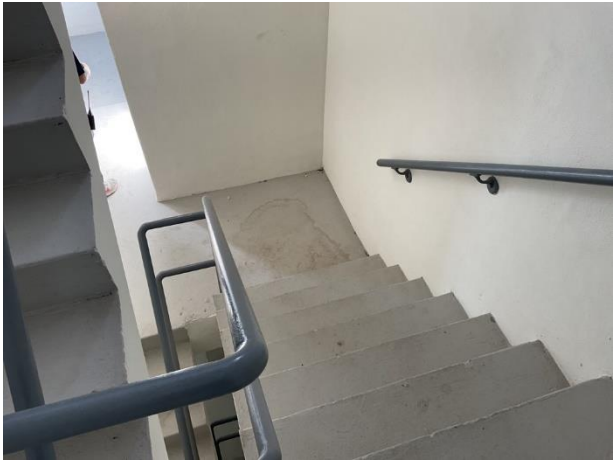
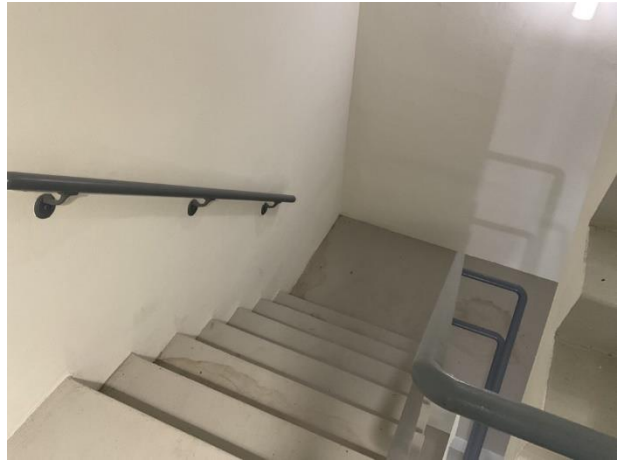
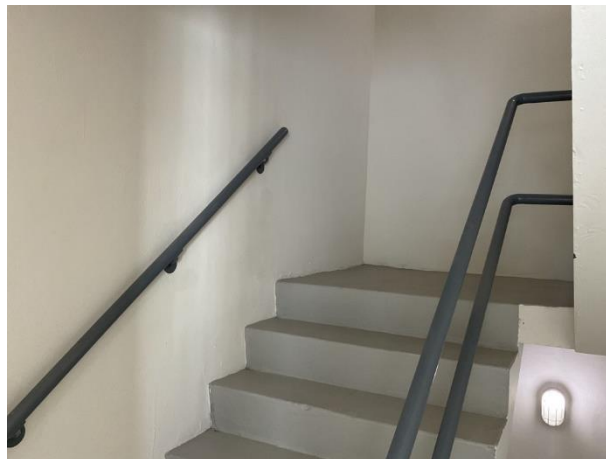
**Conditions:** Good overall with no significant deterioration evident.

Stairwell paint finishes

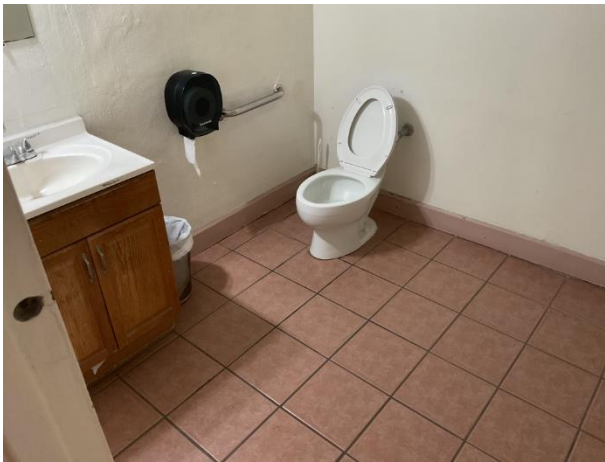
**Condition:** The building rest rooms are in good to fair overall condition and the pool house rest rooms are in fair to poor overall condition with paint deterioration evident.

**Main building rest room overview**

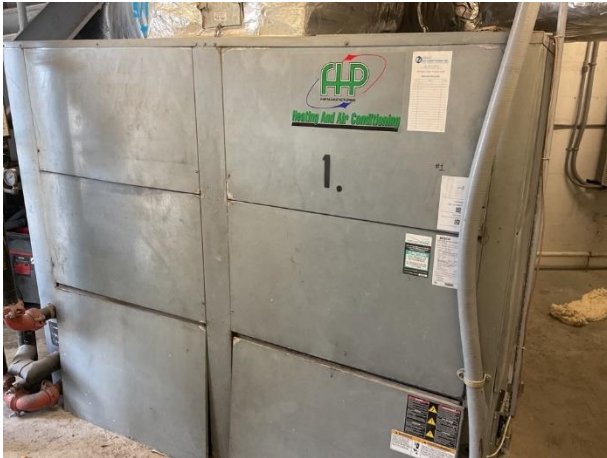
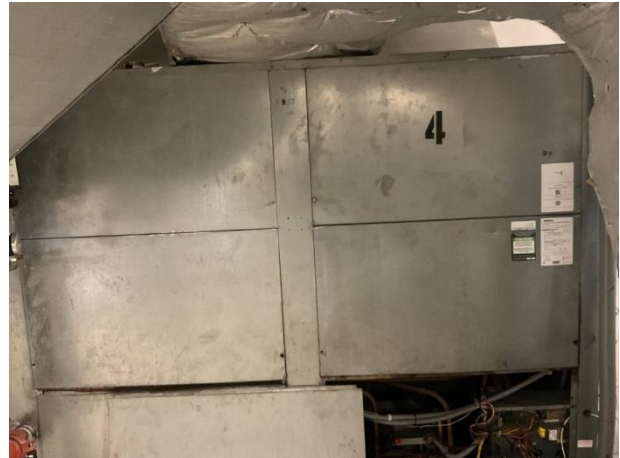
**Conditions:** Reported satisfactory without operational deficiencies

**Air handling unit**

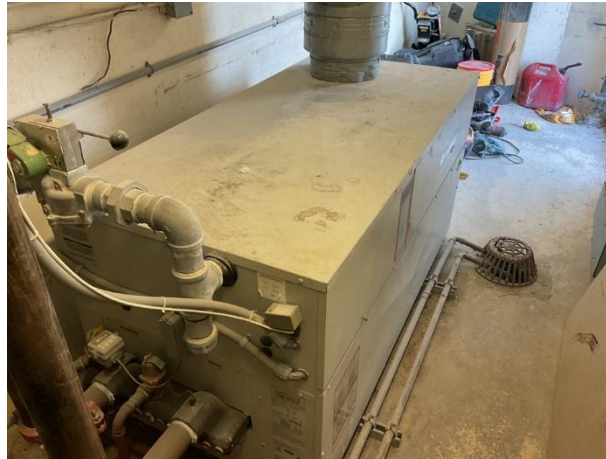
**Condition:** Reported satisfactory without operational deficiencies

**Building heat boiler**

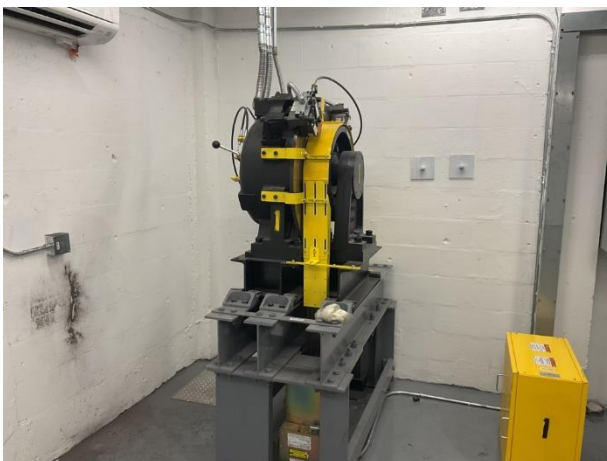
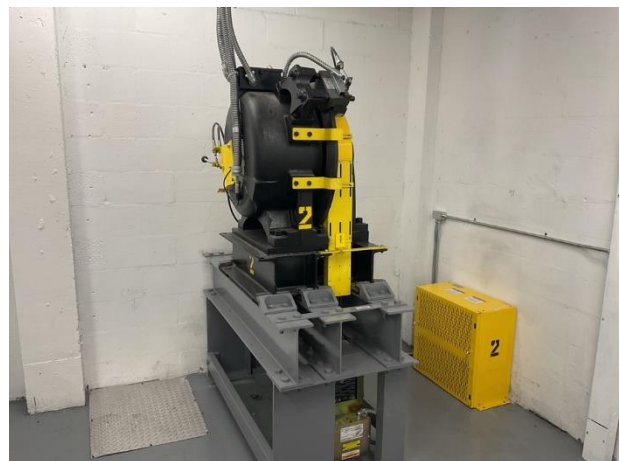
**Condition:** The controls and call buttons are reported in satisfactory condition and the hoists and motors are reported in satisfactory condition. Service interruptions are reportedly infrequent.

**Traction elevator hoist and motor**

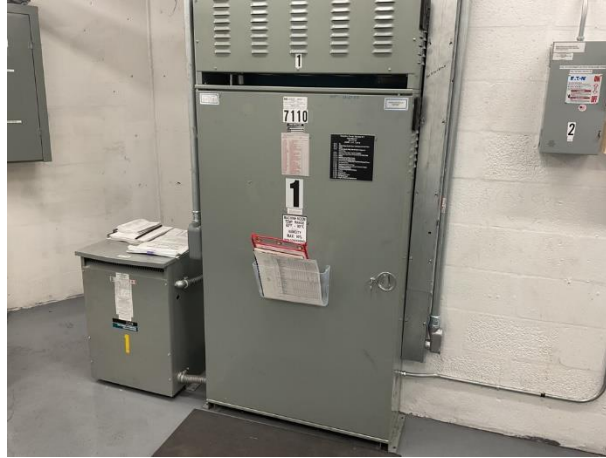
**Traction elevator controls**

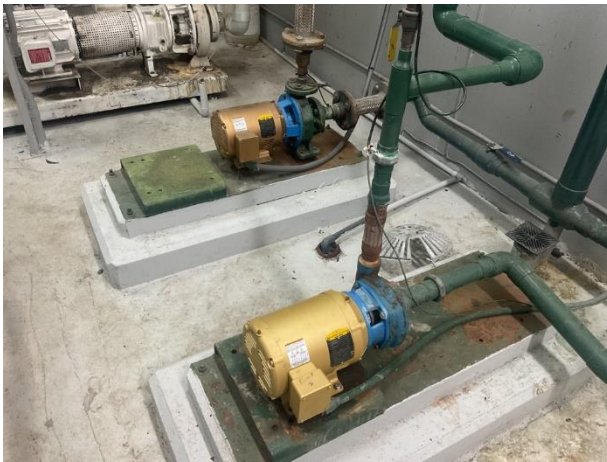
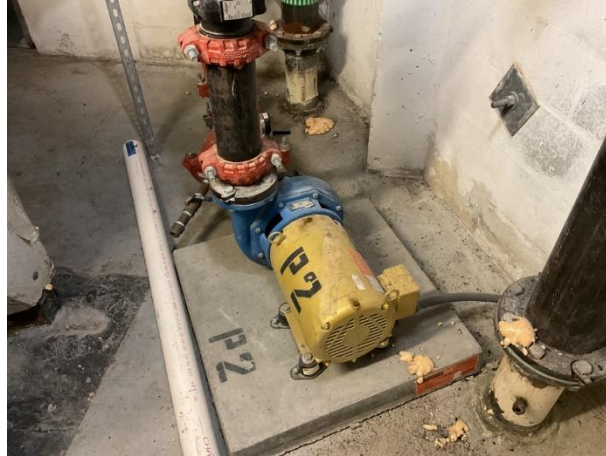
- Cooling Tower - 15-HP, two each, reported satisfactory; The age was unavailable at the time of our inspection.
- Domestic Cold Water - 5-HP, two each, reported satisfactory; The age was unavailable at the time of our inspection.
- Domestic Cold Water - 7.5-HP, one each, reported satisfactory; The age was unavailable at the time of our inspection.

**Domestic water pumps**

**Domestic water pump**

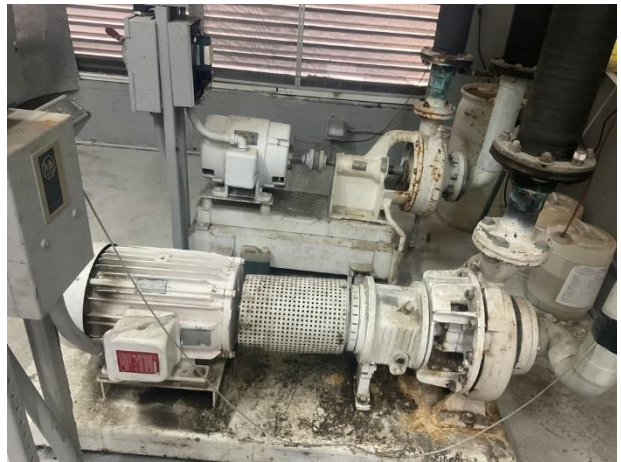
**Cooling tower pumps**

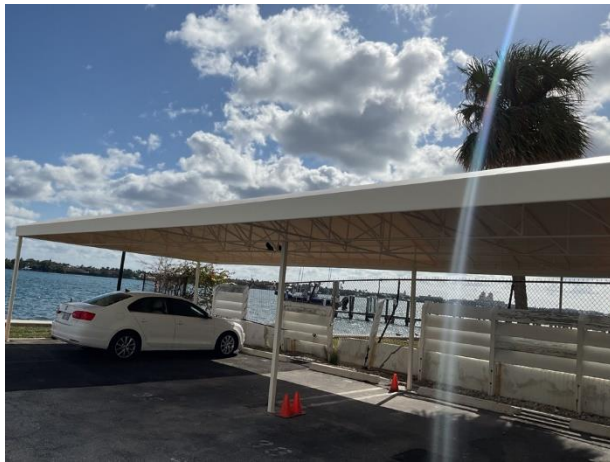
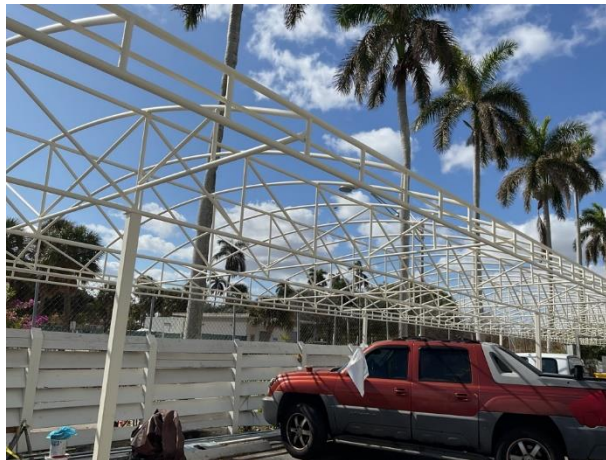
**History and Condition:** The awning was in the process of being replaced at the time of inspection. This project is being funded through means other than reserves.

**Completed section of awning**

**Awning metal frame**

**Awning with canvas being installed**

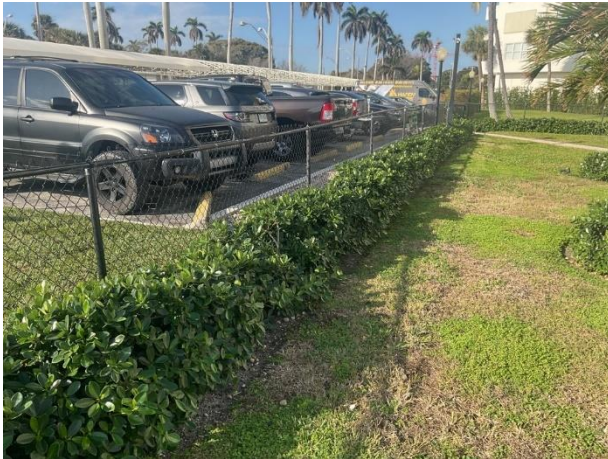
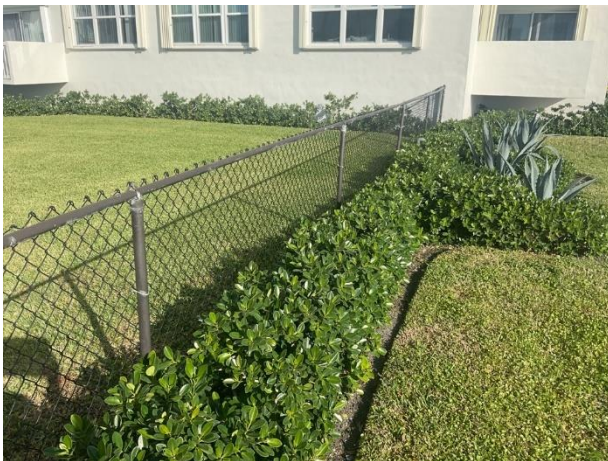
**Condition:** Fair to poor overall with periodic damage evident.

Chain link pool fence

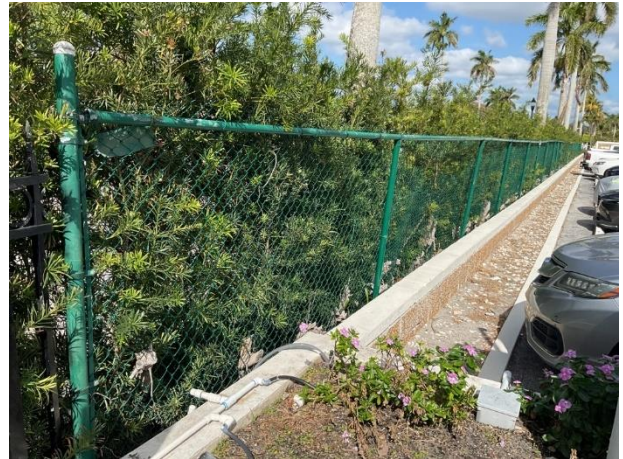
West perimeter chain link fence

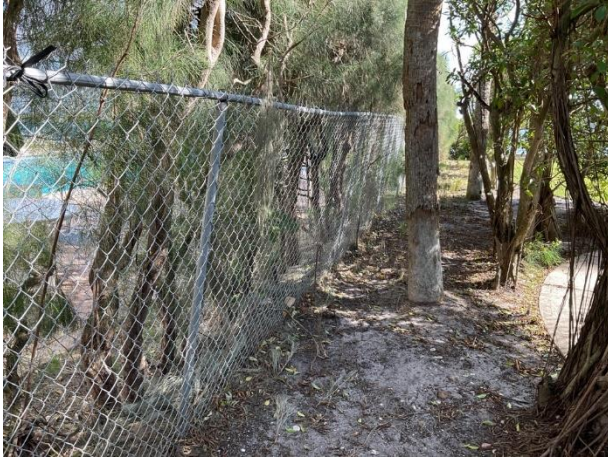
**North perimeter chain link fence**

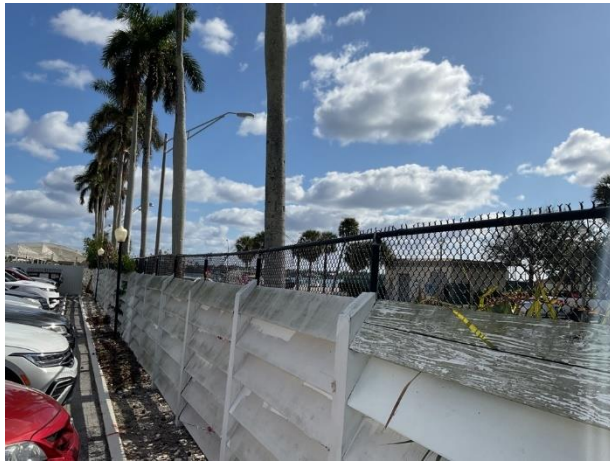
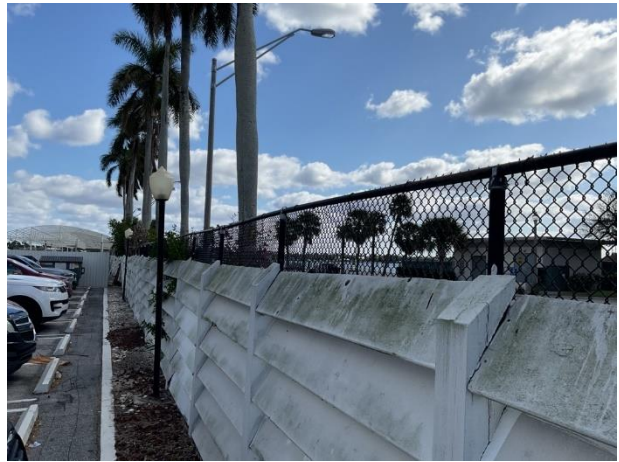
**Condition:** Fair to poor overall with periodic rust evident.

Chain link fence

**History:** The age was unavailable at the time of our inspection. The Association has budgeted to replace the fence in 2025, and we are informed this will be through means other than reserves.

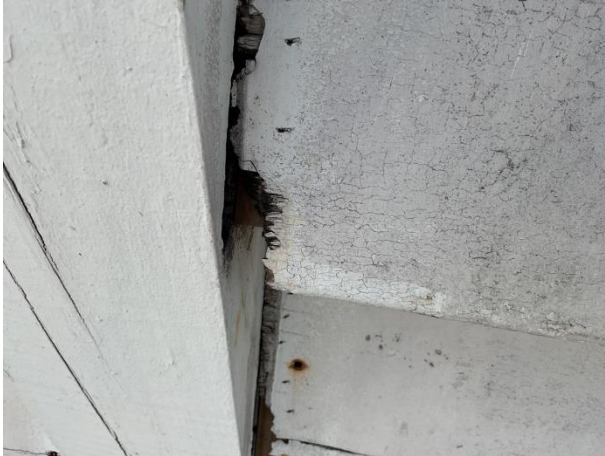
**Condition:** Poor overall with periodic wood rot and paint finish deterioration evident.

**Fence wood rot**

**History:** The age was unavailable at the time of our inspection. The Association has budgeted to replace the fence in 2025, and we are informed this will be through means other than reserves.

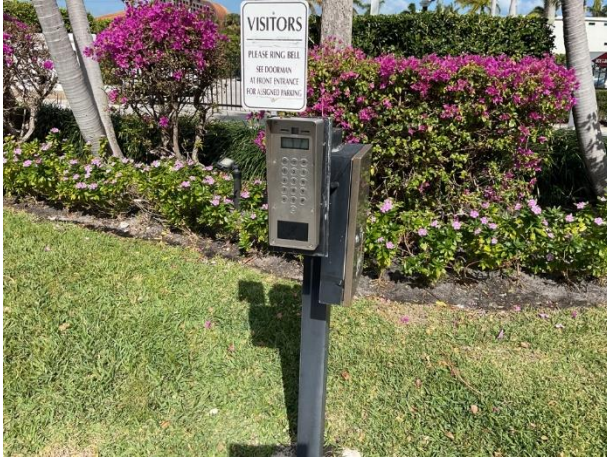
**Condition:** Reported in operational condition.

**Gate entry keypad**

**RFID scanner**

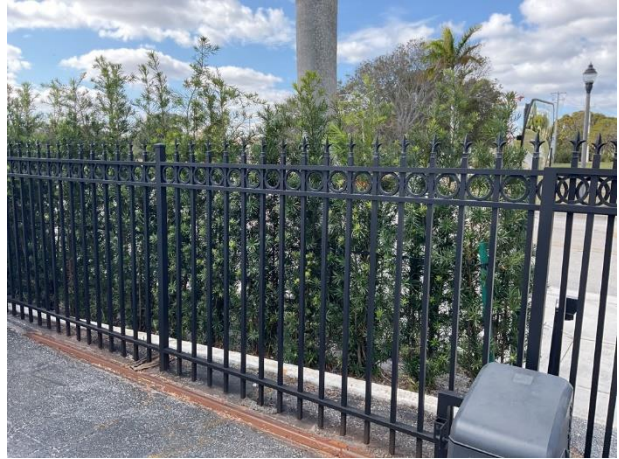
**Fencing at gate**

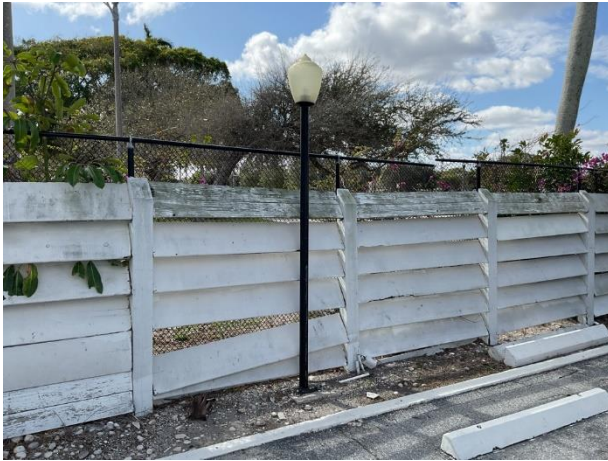
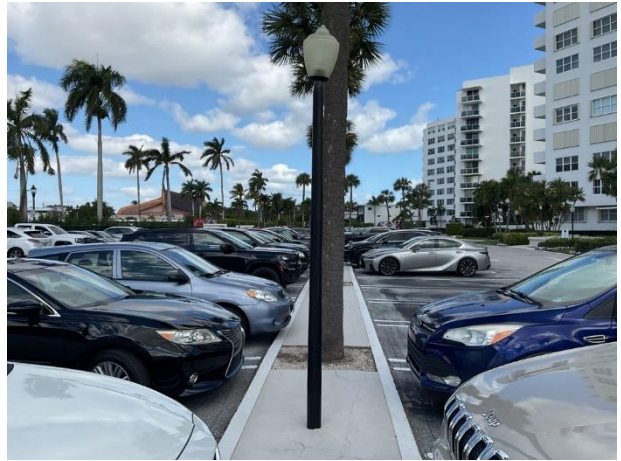
**Condition:** Fair overall with rust and finish deterioration evident.

Light pole and fixture

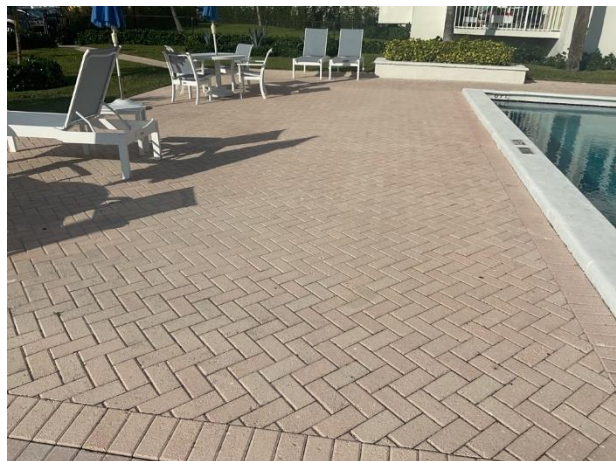
**Condition:** Good to fair overall with isolated settlement evident.

Paver pool deck overview

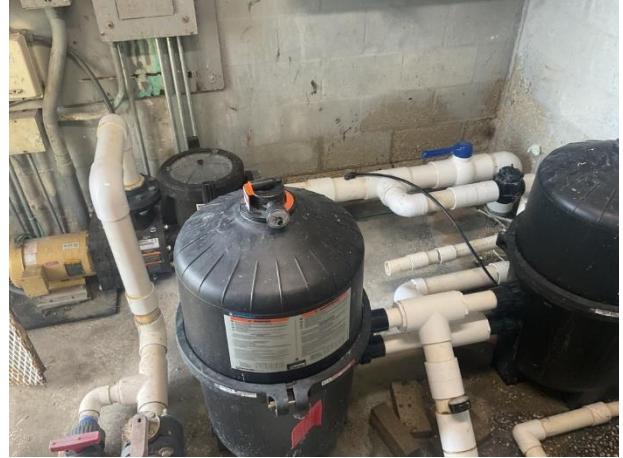
**Condition:** Reported satisfactory without operational deficiencies

**Pool pumps and filters**
