# Portofino Condominium Apts. of Palm Beach, Inc.

Inspected: January 15, 2025 • Revised on: February 07, 2025  
West Palm Beach, FL

**STRUCTURAL INTEGRITY  
RESERVE STUDY**

**PORTOFINO  
2600**

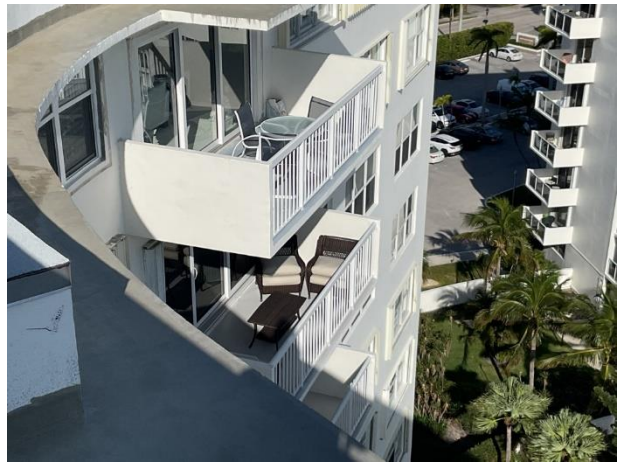
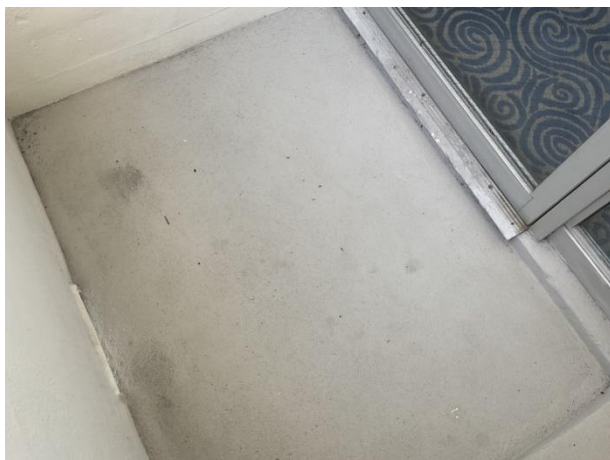
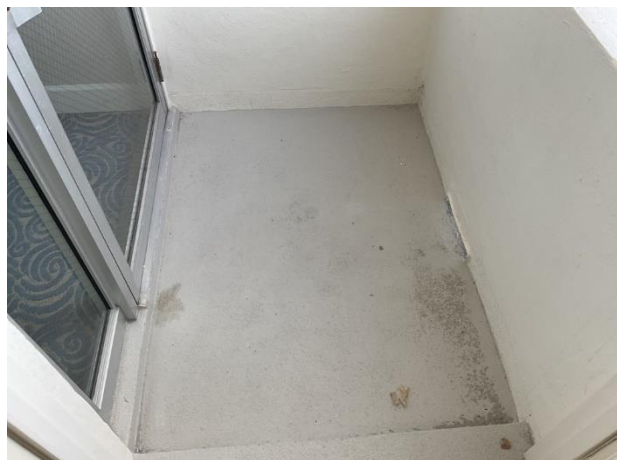
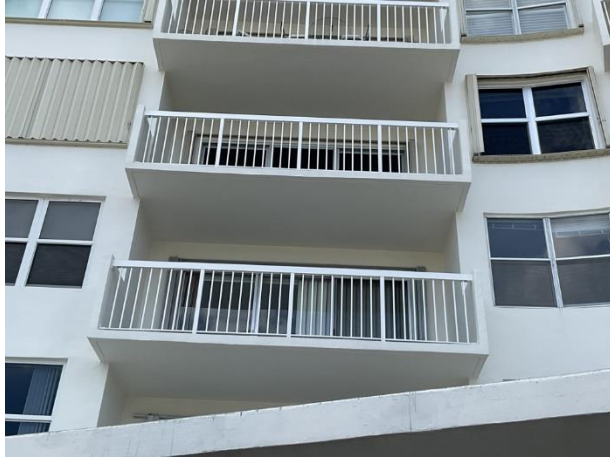
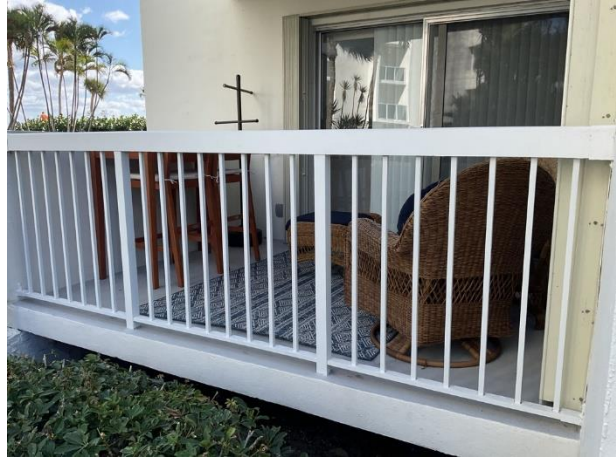
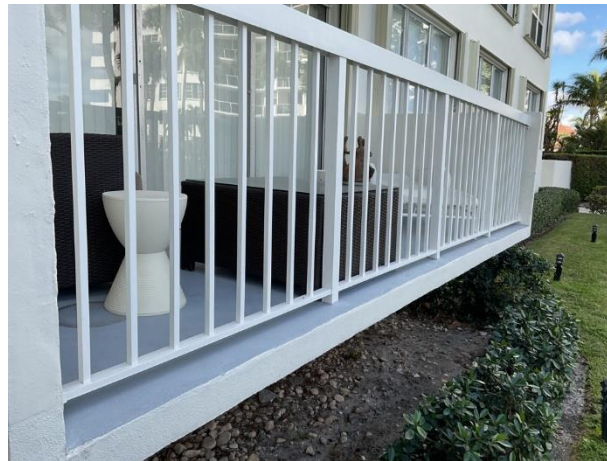
**Condition:** Good overall with no significant deterioration evident. We note the following:

- Sealants are in good condition
- The coatings are in good condition

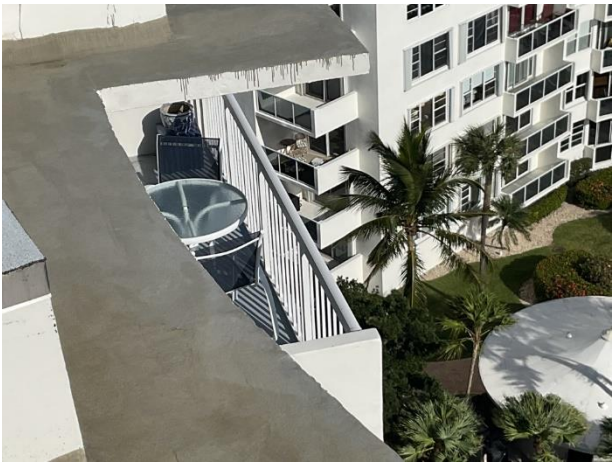
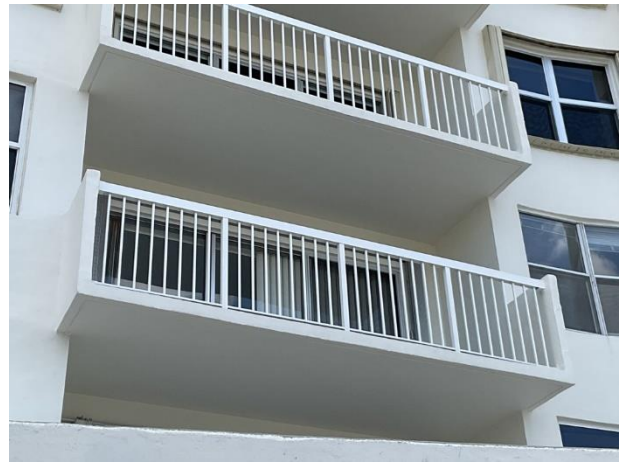
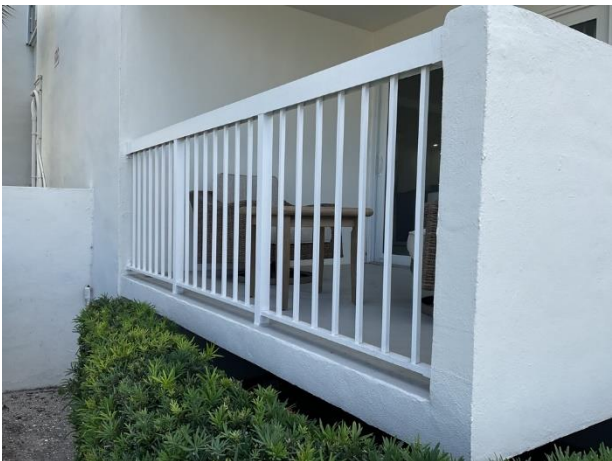
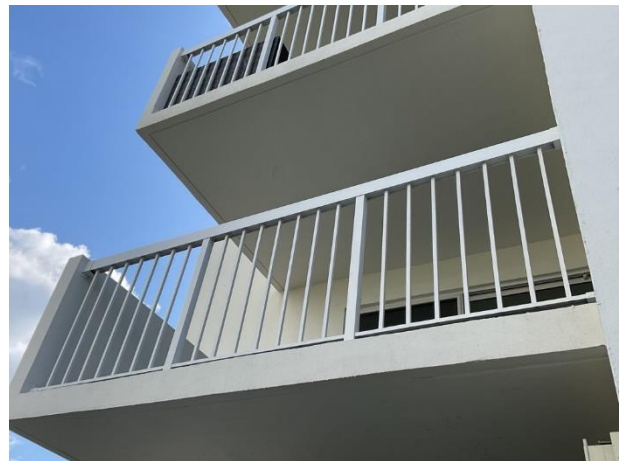
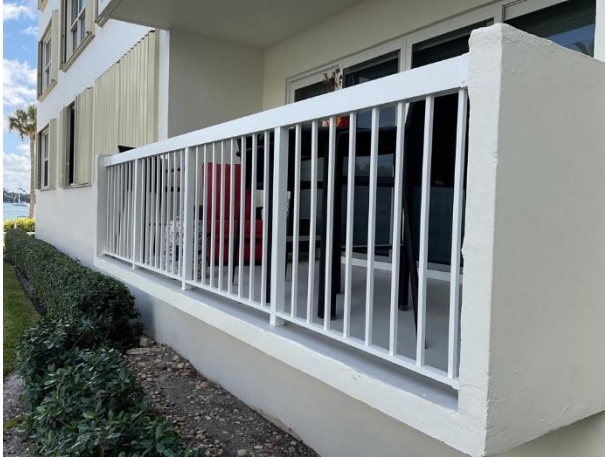
**Conditions:** The railings are in good overall condition and the railing finishes are in good condition with no significant deterioration evident.

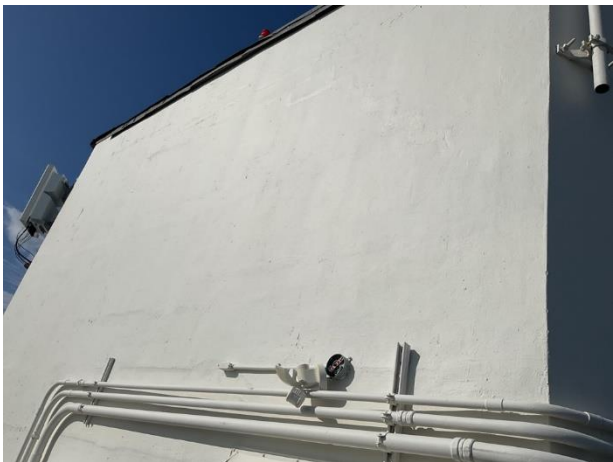
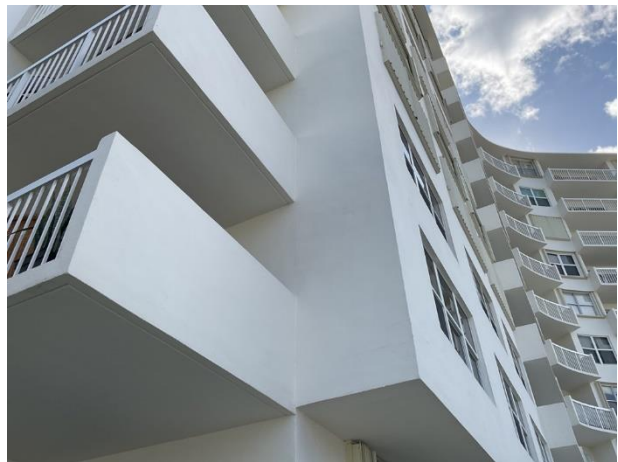
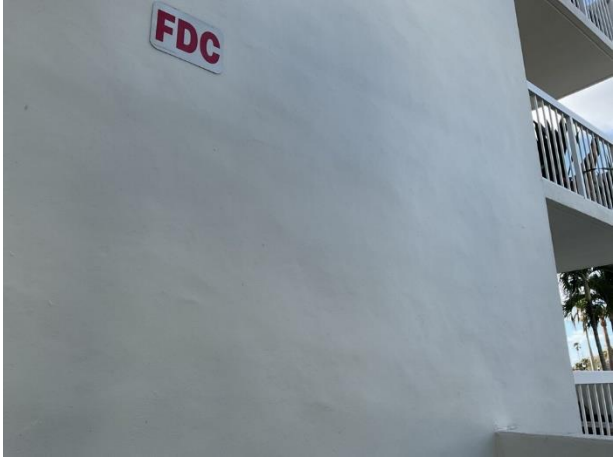
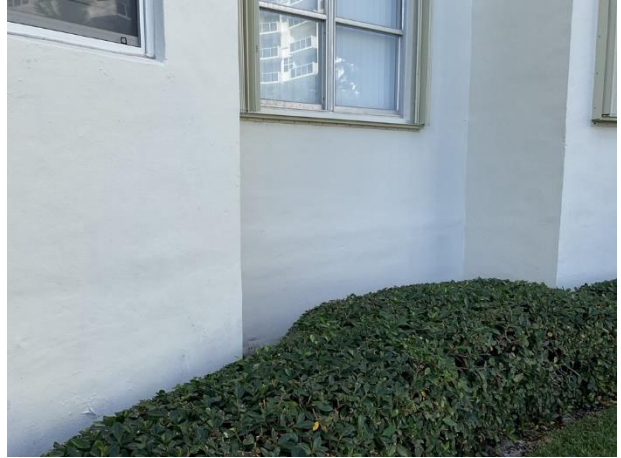
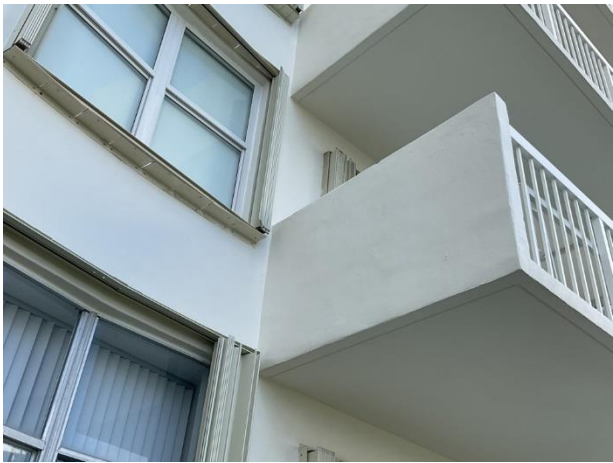
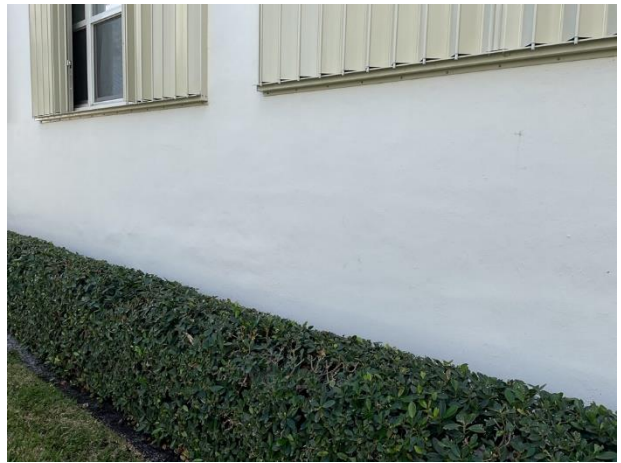
**Condition:** Good overall with no significant deterioration evident. We note the following:

- Sealants are in good condition

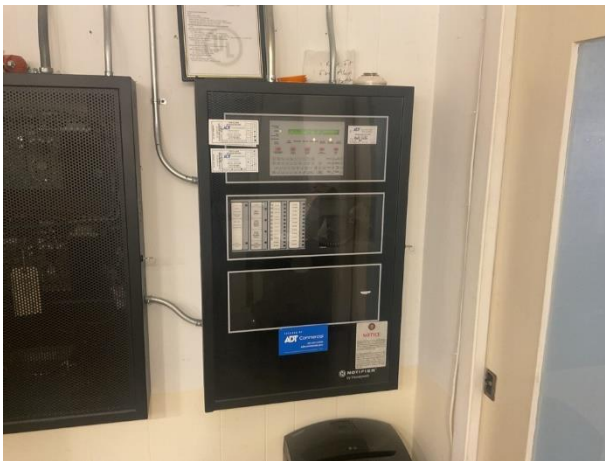
**Conditions:** Reported satisfactory without operational deficiencies. The life safety system was last inspected on January 17, 2024. The life safety system was tagged acceptable during the most recent inspection.

**Control panel**

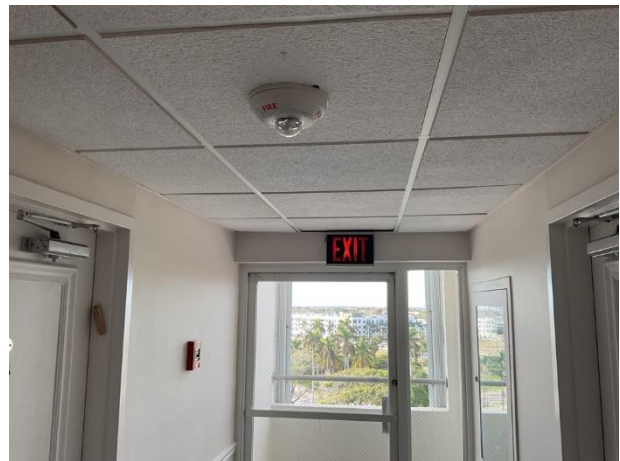
**Emergency devices**

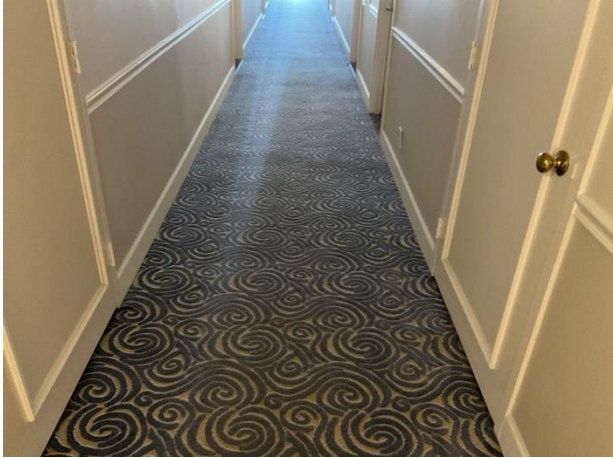
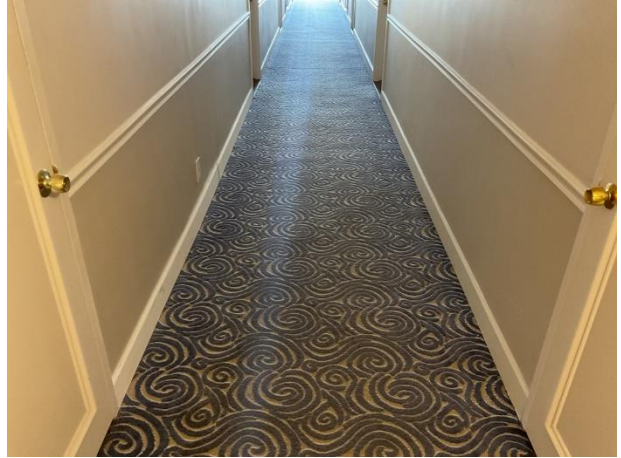
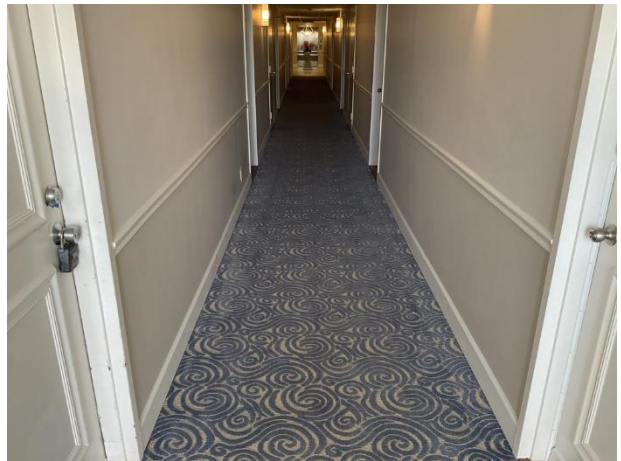
**Condition:** Good overall with no significant deterioration evident.

**Carpet floor coverings**

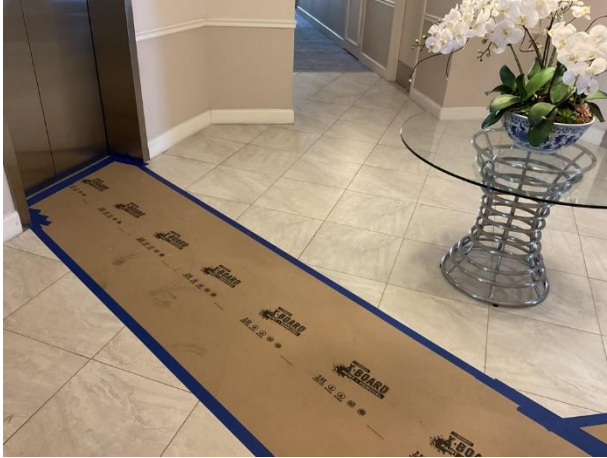
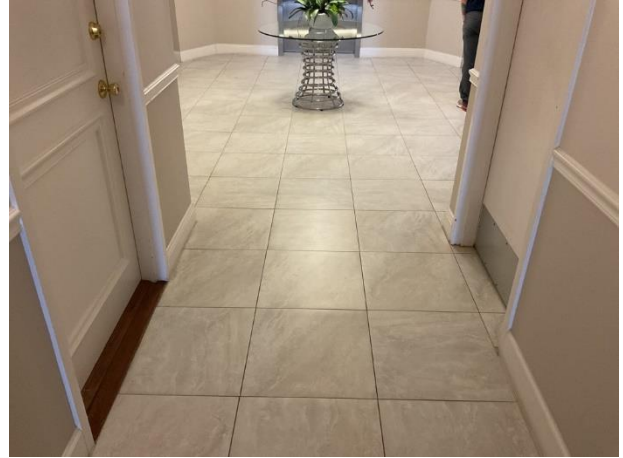
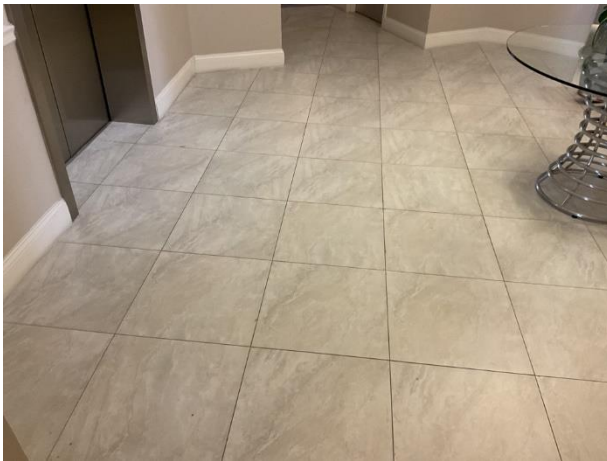
**Condition:** Good overall with no significant deterioration evident.

**Tile floor coverings**

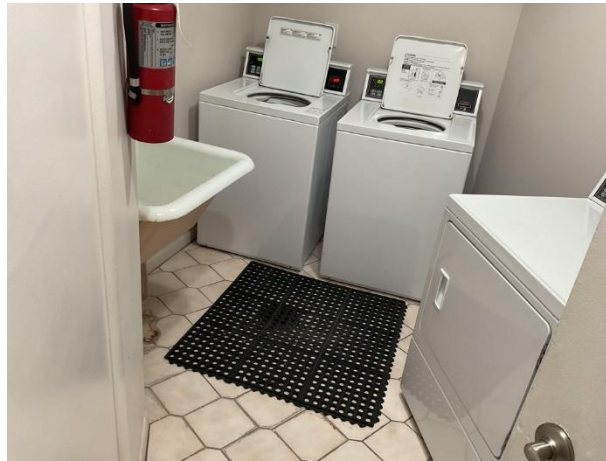
**Condition:** Fair overall

**Laundry room overview**

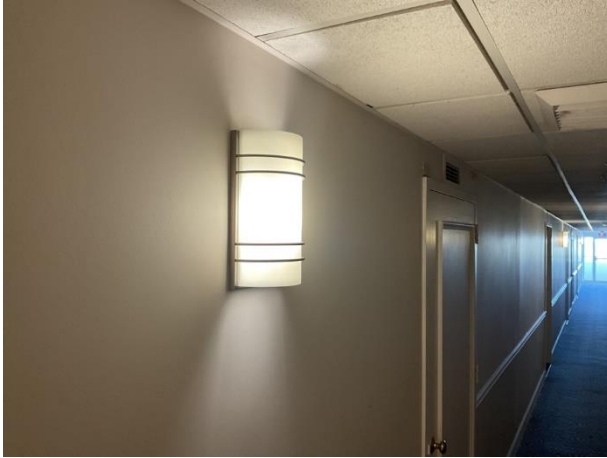
**Condition:** Reported satisfactory overall with no significant deterioration evident.

**Wall mounted light fixture**

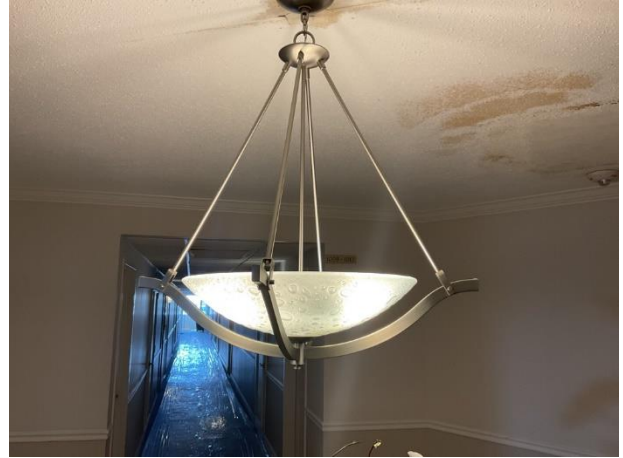
**Ceiling mounted light fixture**

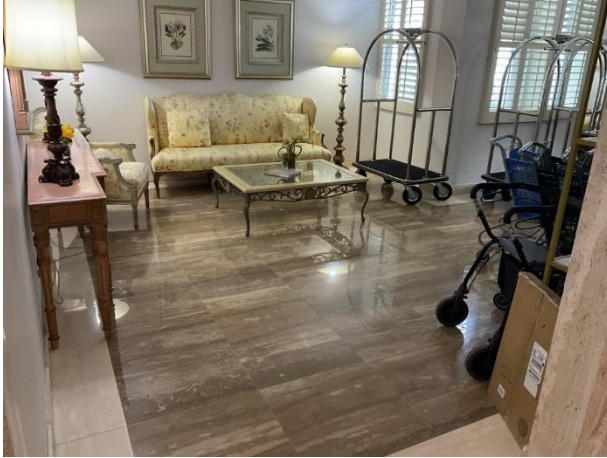
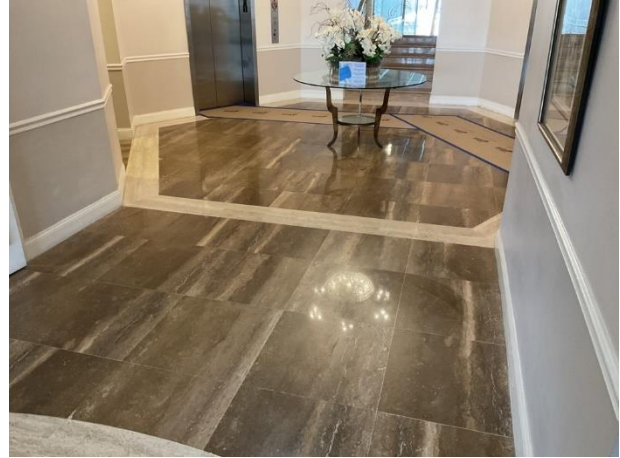
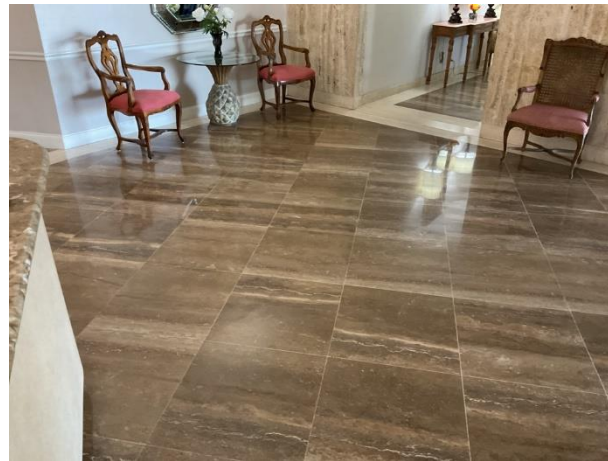
**Condition:** Good overall with no significant deterioration evident.

**Lobby overview**

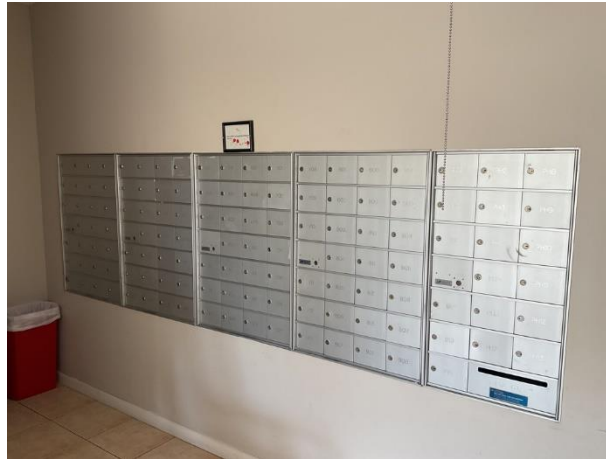
**Condition:** Reported satisfactory overall

**Mailboxes**

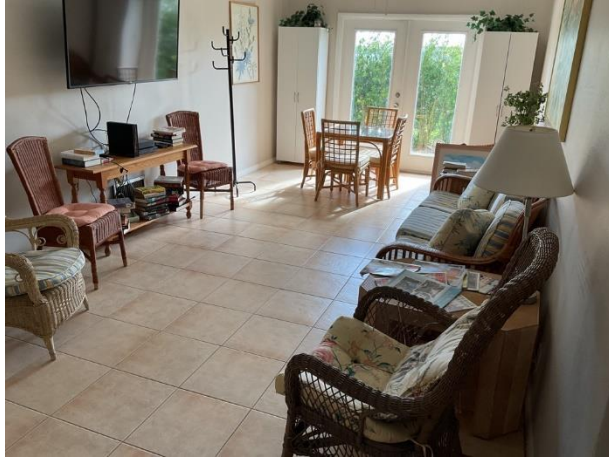
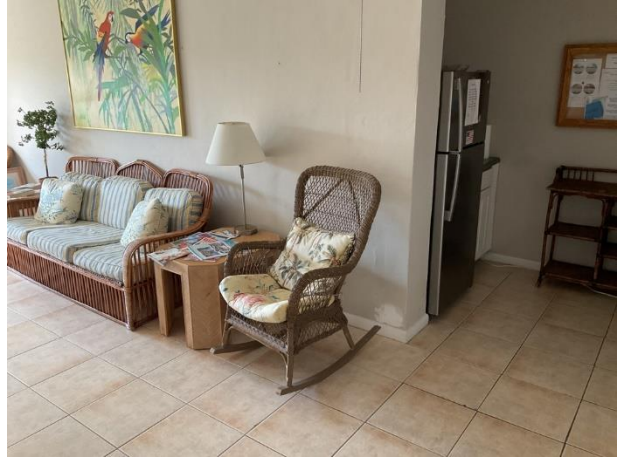
**Condition:** Good to fair overall with previous wall repairs evident.

**Mediterranean room overview**

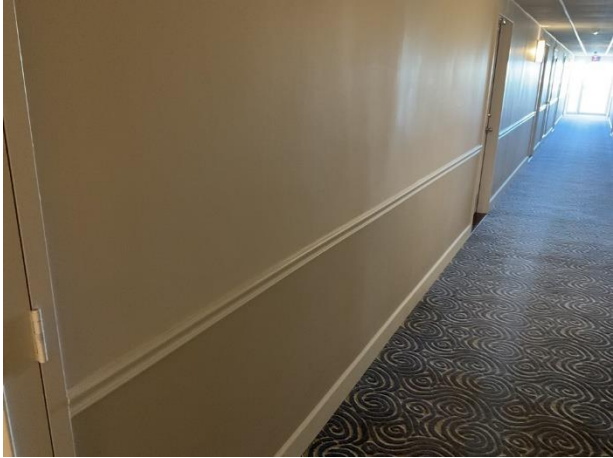
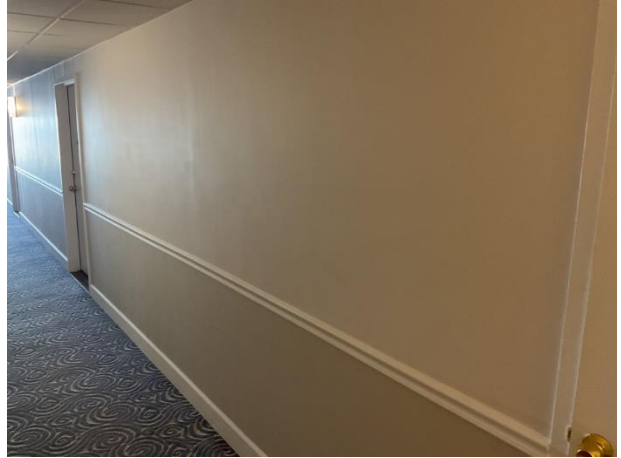
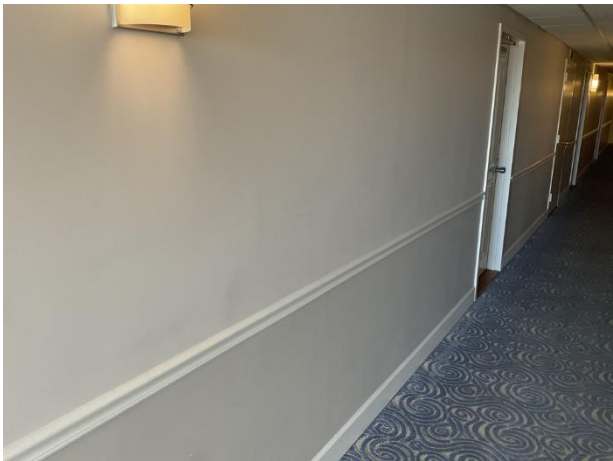
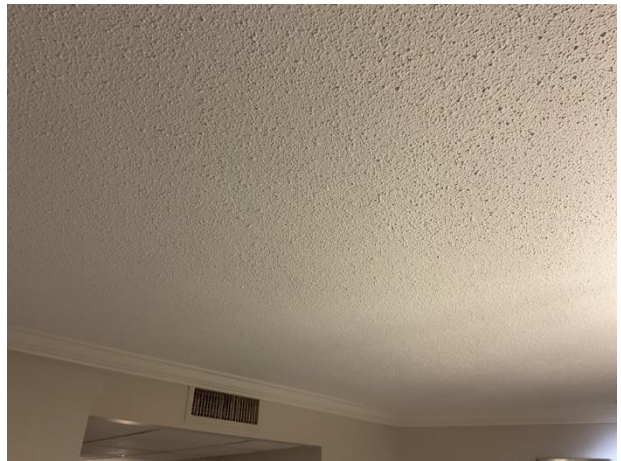
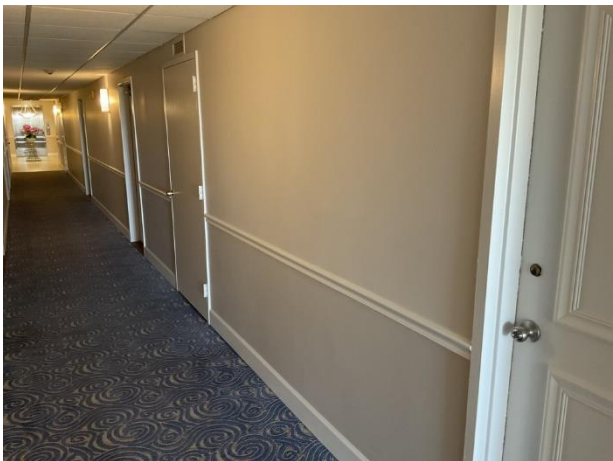
**Condition:** Good overall; We note one section of stains that occurred due to water damage.

**Paint finishes overview**

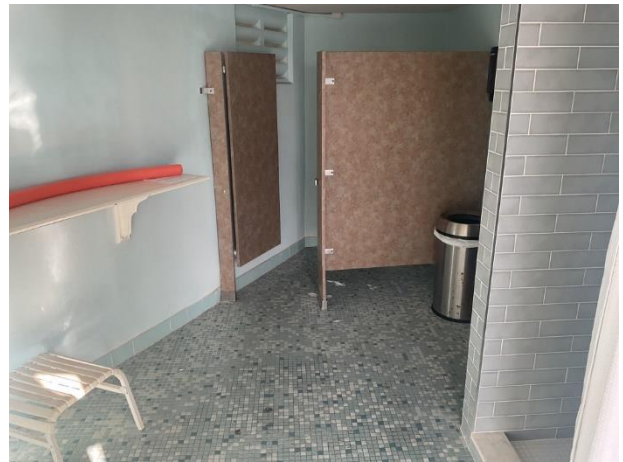
**Condition:** The building rest rooms are in good to fair overall condition and the pool house rest rooms are in fair to poor overall condition with paint deterioration evident.

**Pool house rest room overview**

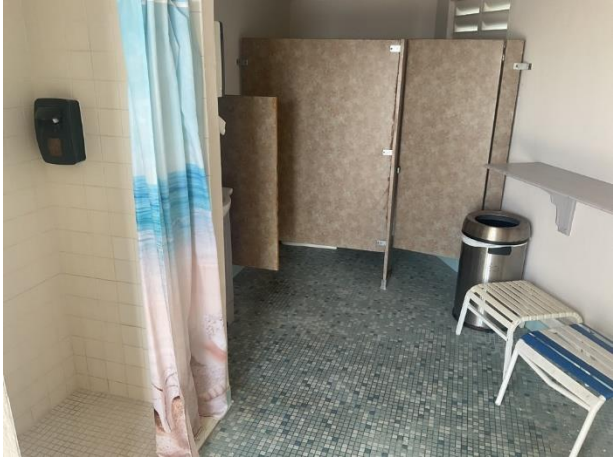
**Pool house rest room overview**

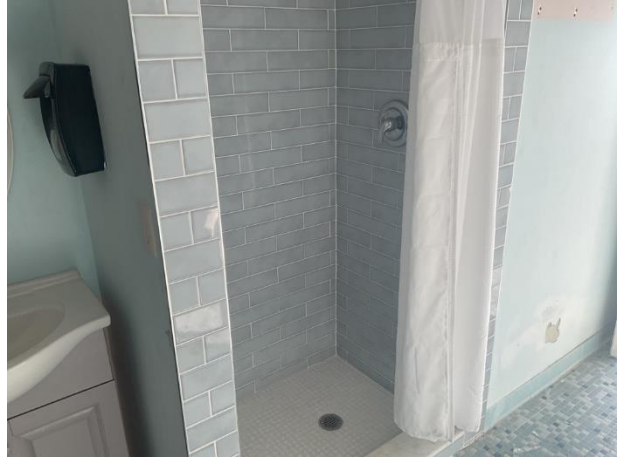
**Refinished shower**

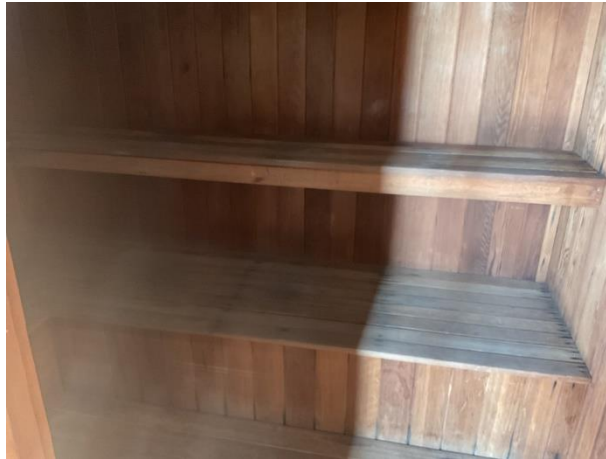
**Condition:** Reported in satisfactory condition

**Sauna overview**

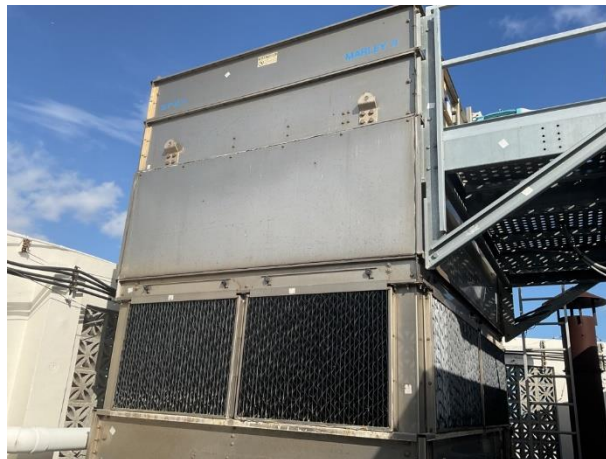
**Condition:** Reported satisfactory without operational deficiencies

**Cooling tower**

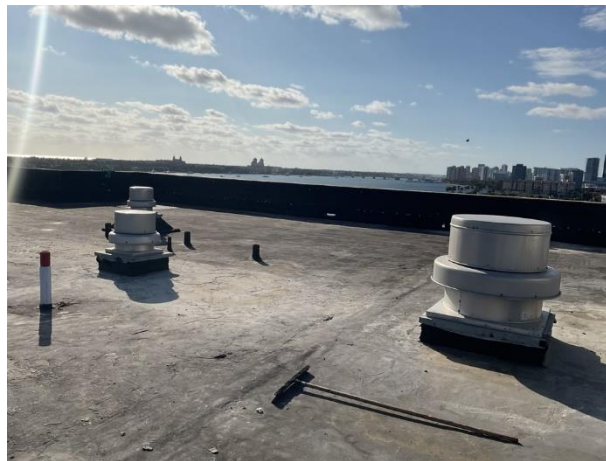
**Condition:** Reported satisfactory without operational deficiencies

Exhaust fans

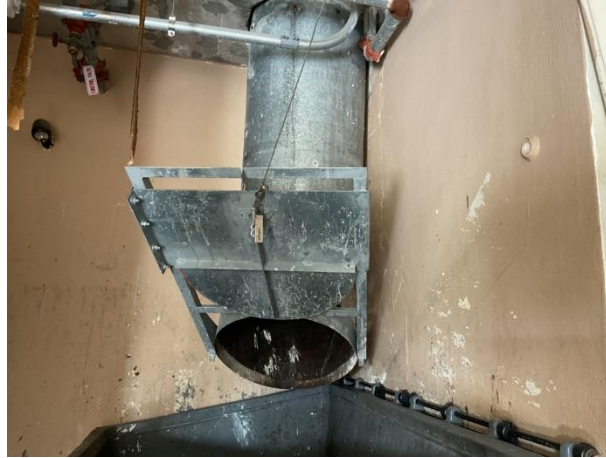
**Condition:** Reported satisfactory without operational deficiencies

**Trash chute**

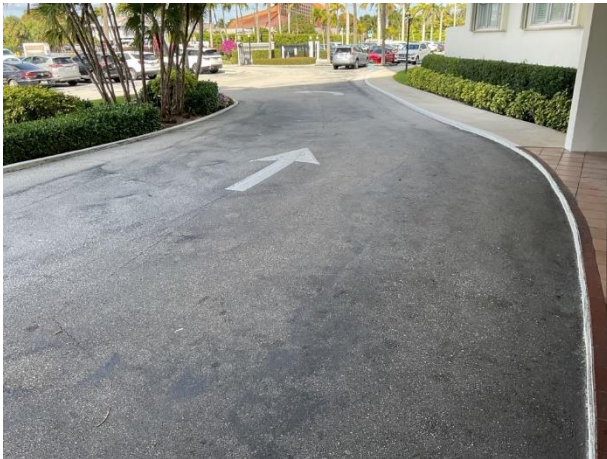
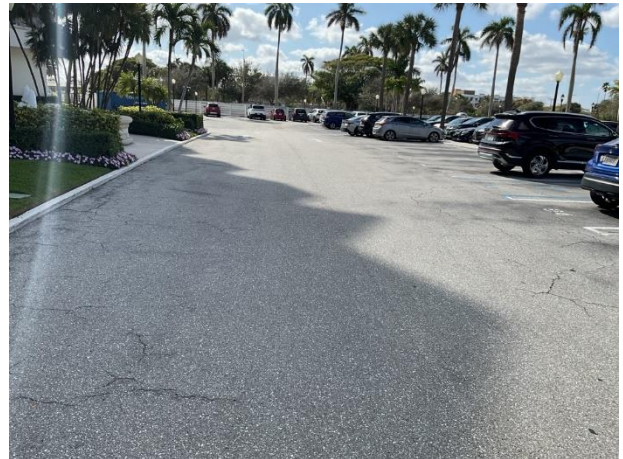
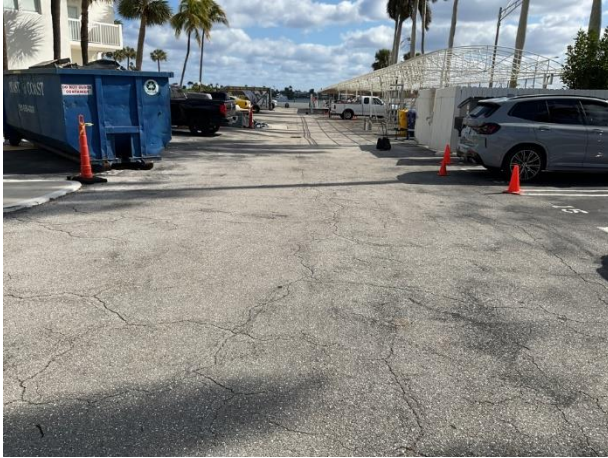
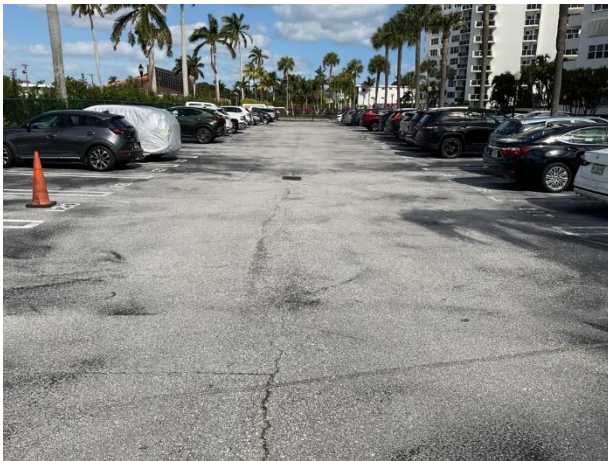
**Condition:** Fair overall with periodic cracks and seal coat deterioration evident. We note centerline deterioration at the pavement due to the drainage system.

Pavement overview

**Pavement overview**

The manner of repaving is either a mill and overlay or total replacement. A mill and overlay is a method of repaving where cracked, worn and failed pavement is mechanically removed or milled until sound pavement is found. A new layer of asphalt is overlaid atop the remaining base course of pavement. Total replacement includes the removal of all existing asphalt down to the base course of aggregate and native soil followed by the application of two or more new lifts of asphalt. We recommend mill and overlayment on asphalt pavement that exhibits normal deterioration and wear. We recommend total replacement of asphalt pavement that exhibits severe deterioration, inadequate drainage, pavement that has been overlaid multiple times in the past or where the configuration makes overlayment not possible. Based on the apparent visual condition and configuration of the asphalt pavement, we recommend the mill and overlay method of repaving at Portofino.

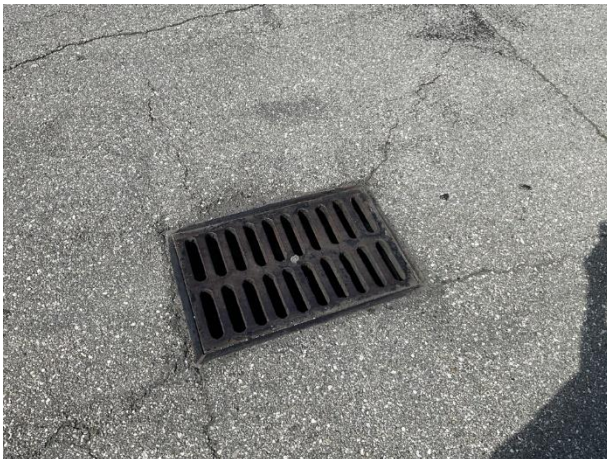
Catch basin

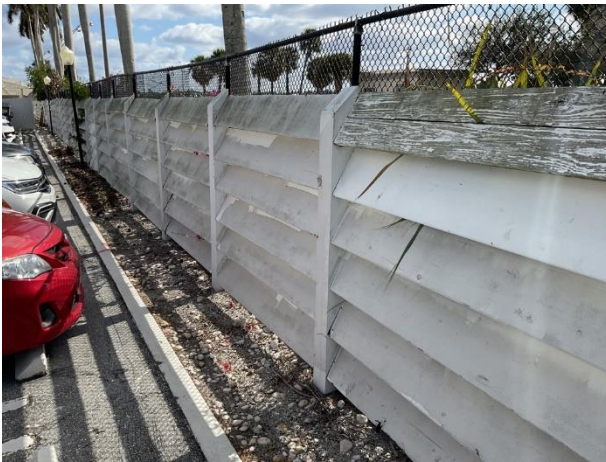
**Condition:** Poor overall with periodic wood rot and paint finish deterioration evident.

**Wood fence**

**History:** The age was unavailable at the time of our inspection. The Association has budgeted to replace the fence in 2025, and we are informed this will be through means other than reserves.

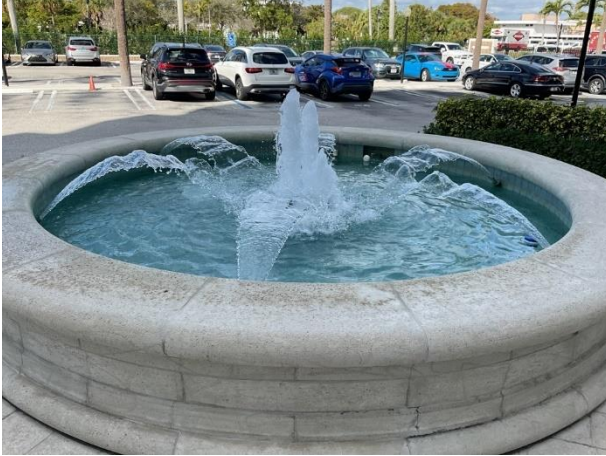
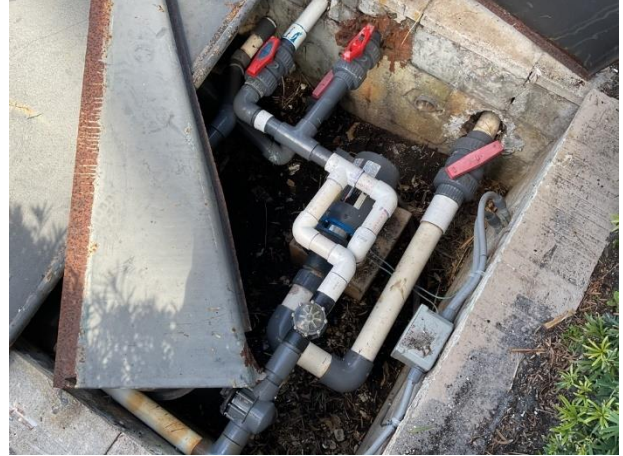
**Condition:** Reported satisfactory overall

**Fountain overview**

**Fountain equipment**

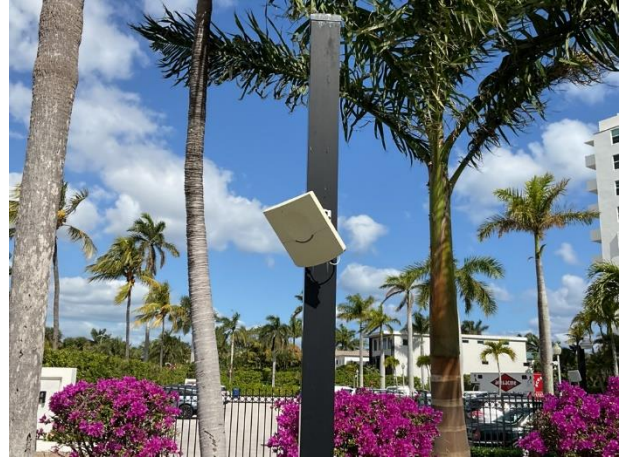
**Condition:** Reported in operational condition.

**Gate entry keypad**

**RFID scanner**

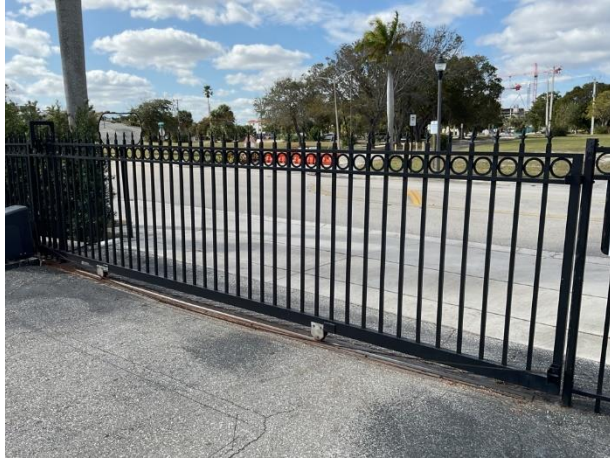
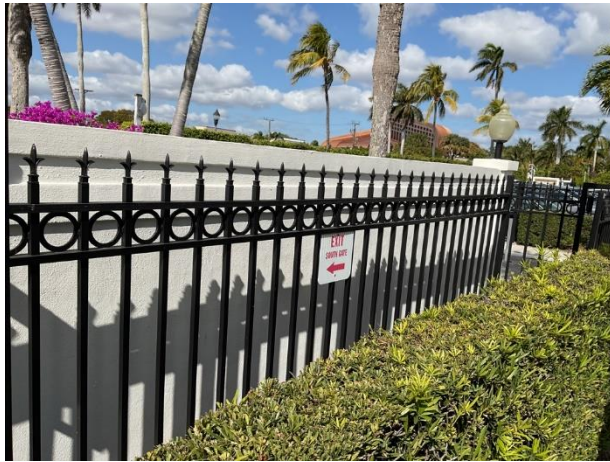
- Gates: Fair overall condition

**Aluminum gate**

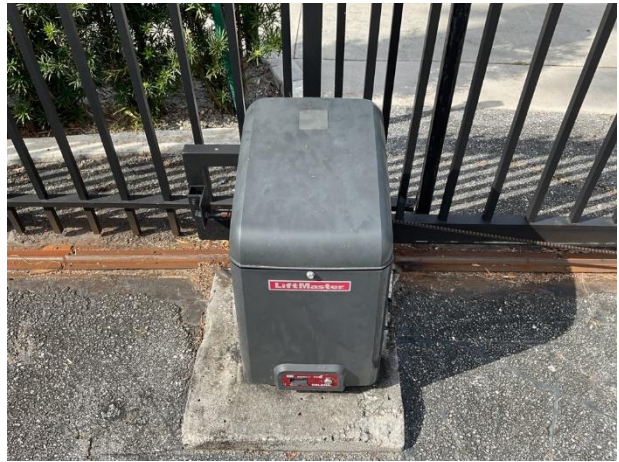
**Gate operator**

**Preventative Maintenance Notes:** The Association informs us preventative maintenance is conducted on a regular basis. We recommend the Association obtain

and adhere to the manufacturer's recommended maintenance plan. The required preventative maintenance may vary in frequency and scope based on the unit's age, operational condition, or changes in technology. We note the following select recommended preventative maintenance activities to maximize the remaining useful life:

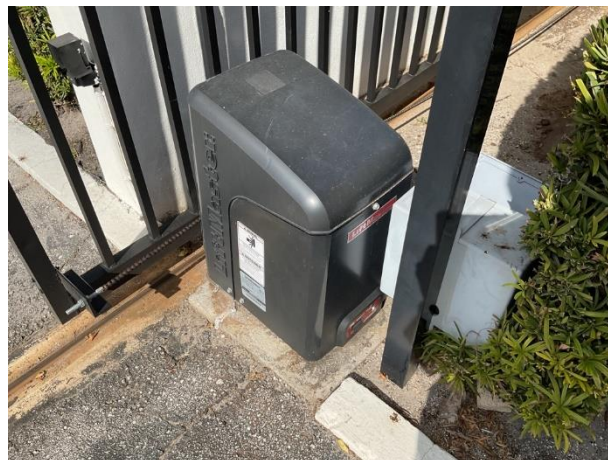
**Gate operator**

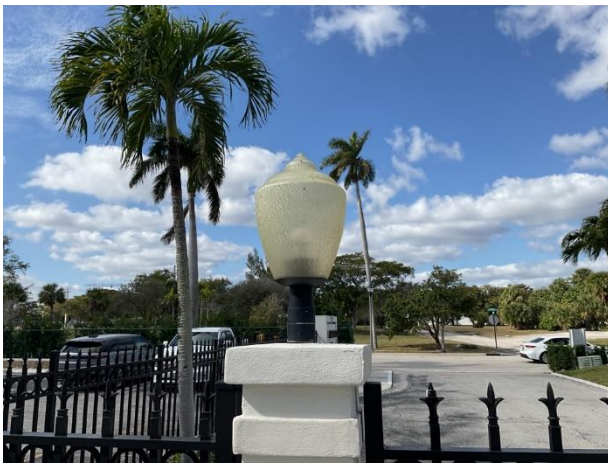
**Condition:** Fair overall with rust and finish deterioration evident.

Light fixture

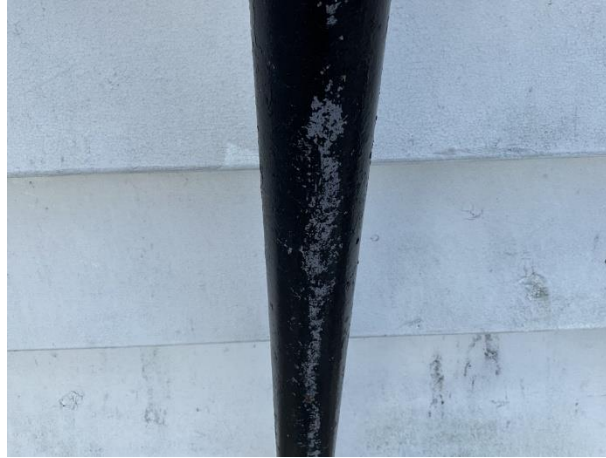
**Finish deterioration**

- As-needed:
  - Inspect and repair broken or dislodged fixtures, and leaning or damaged poles
  - Replaced burned out bulbs as needed

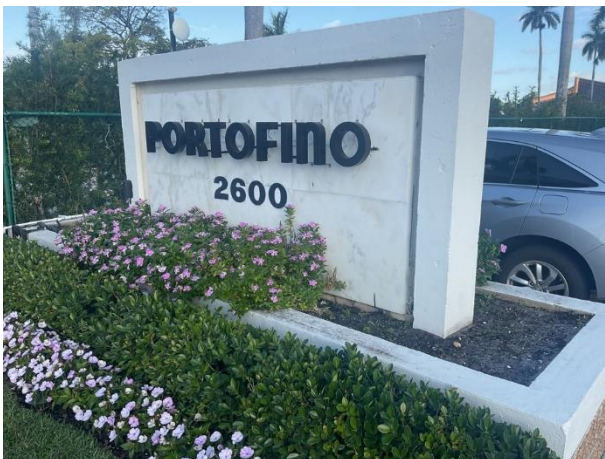
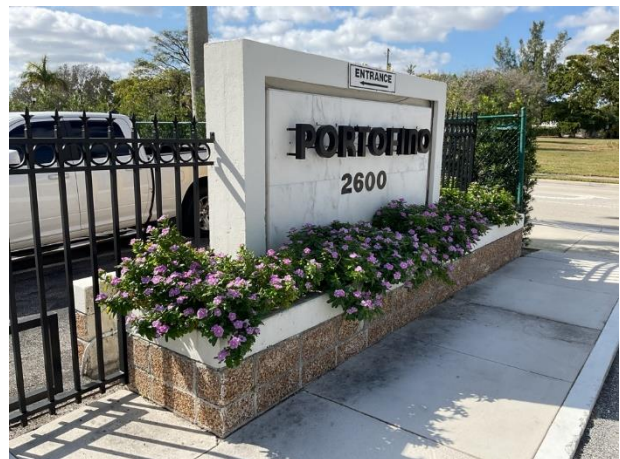
**Condition:** Good overall

Entrance monument

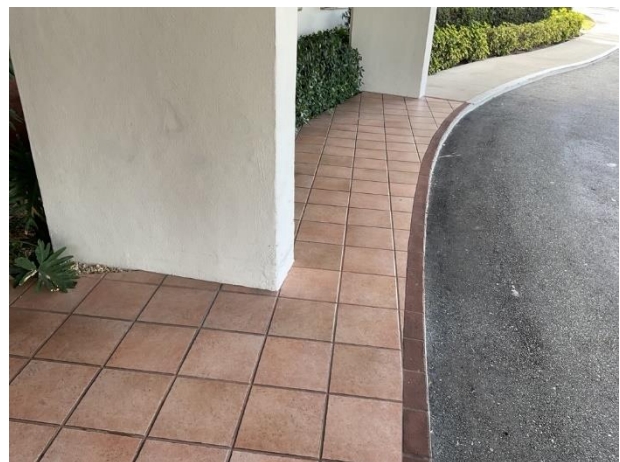
**Condition:** Good overall

**Tile floor coverings**

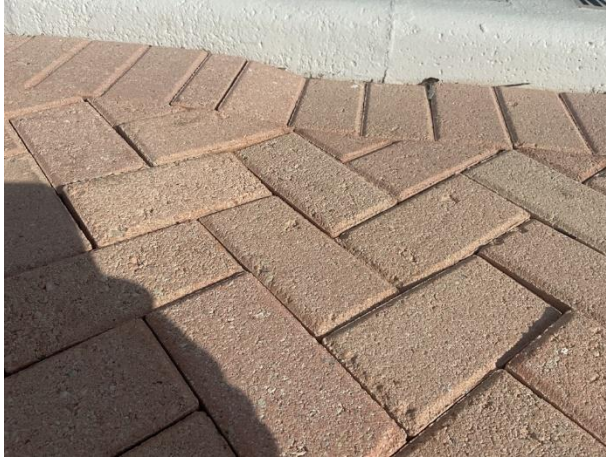
**Condition:** Good to fair overall with isolated settlement evident.

**Paver settlement**

- Annually:
  - Inspect and repair settlement, trip hazards and significant paver spall
  - Reset and/or reseal damaged pavers as necessary
  - Periodically clean and remove overgrown vegetation as needed

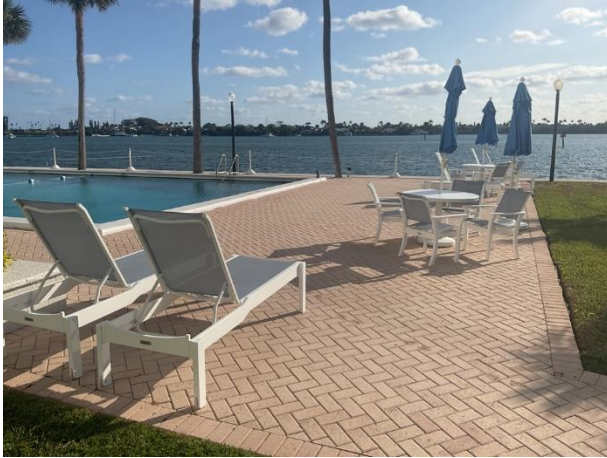
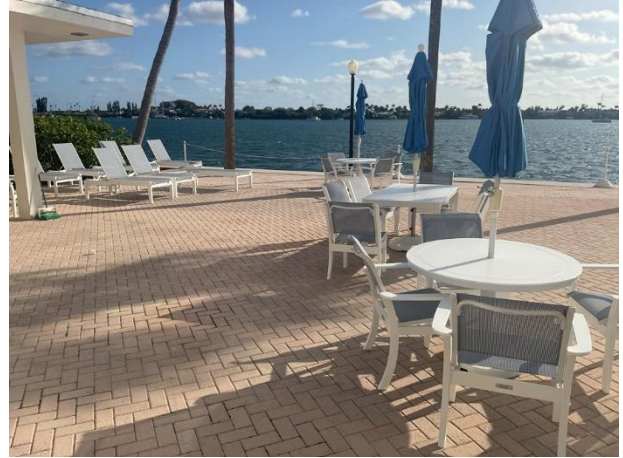
**Condition:** Good overall

**Pool furniture**

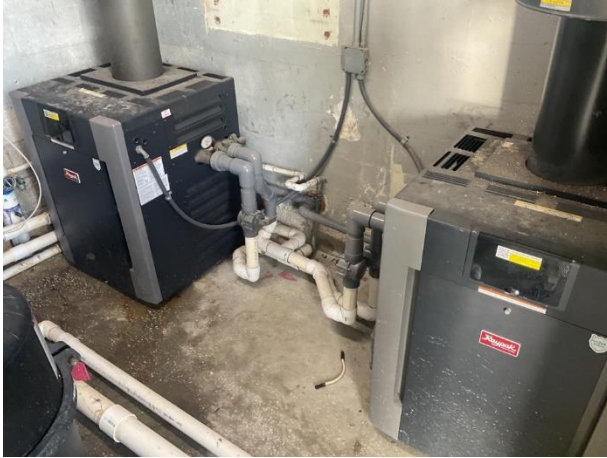
**Condition:** Reported satisfactory without operational deficiencies

**Pool heaters**

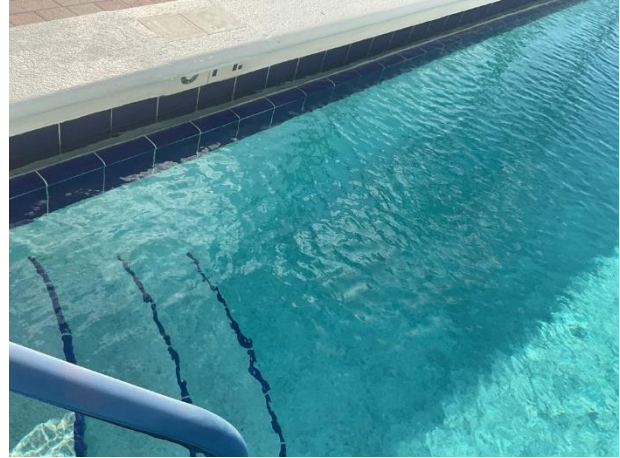
**Condition:** Fair overall with periodic discoloration evident.

**Pool plaster finish with tile perimeter**

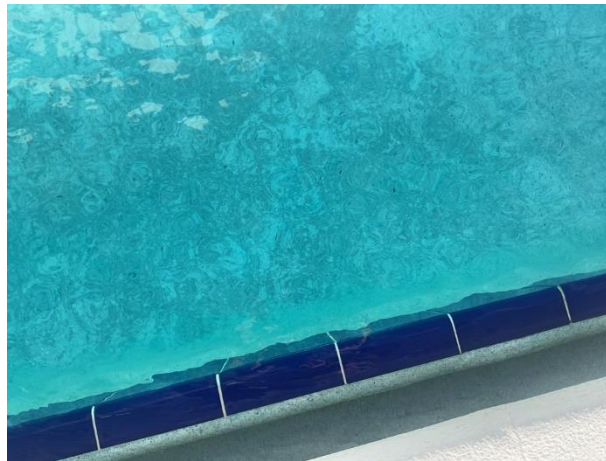
**Plaster discoloration**

- Removal and replacement of the plaster finish
- Partial replacements of the scuppers and coping as needed
- Replacement of tiles as needed
- Replacement of joint sealants as needed
- Concrete structure repairs as needed

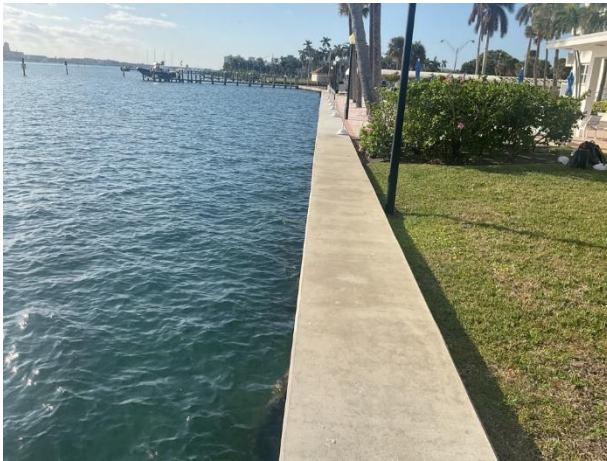
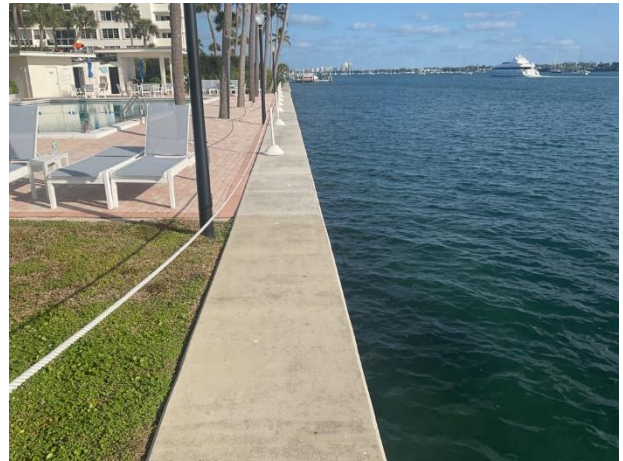
**Conditions:** Fair overall; We note isolated cracks and one section with evidence of water infiltration causing erosion and paver settlement.

Concrete bulkhead

**History:** The age was unavailable at the time of our inspection. Repairs are planned to be made in 2026 after the roofing project is complete and this will be funded through means other than reserves.
